HERITAGE AT RISK IN HARTLEPOOL 2013

State of the historic environment in Hartlepool at a glance

This document was agreed by Planning Committee on 25th September 2013. It is the Council's intention to review this list annually to ensure that the information contained is correct and an accurate reflection of Heritage at Risk in Hartlepool.

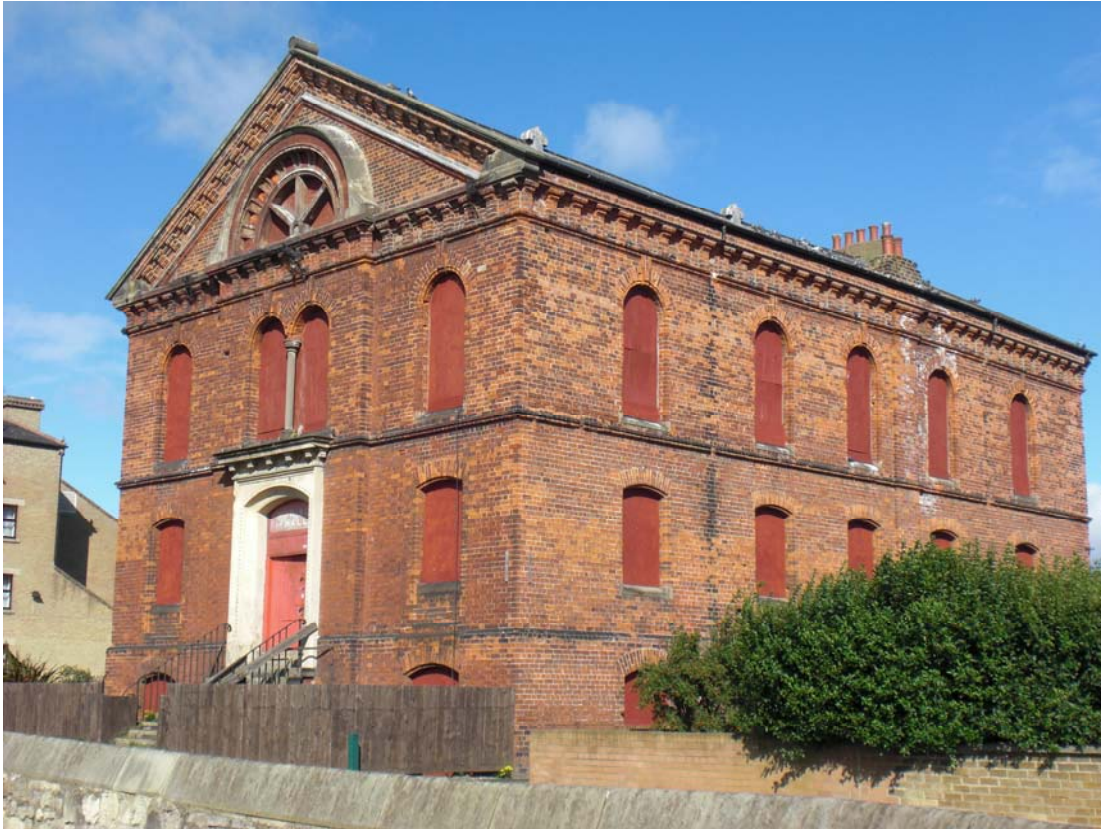
Morison Hall, Church Close

Condition *Poor*

The external fabric of the property is in a reasonable condition. A grant was provided in 1998 for re-roofing and structural works. The building has been secured with windows and doors boarded to prevent entry. Recent internal inspections suggest that little maintenance of the building has taken place since it became vacant. There is some limited damage to the interior from the fire but the property appears, for the most part, to be sound.

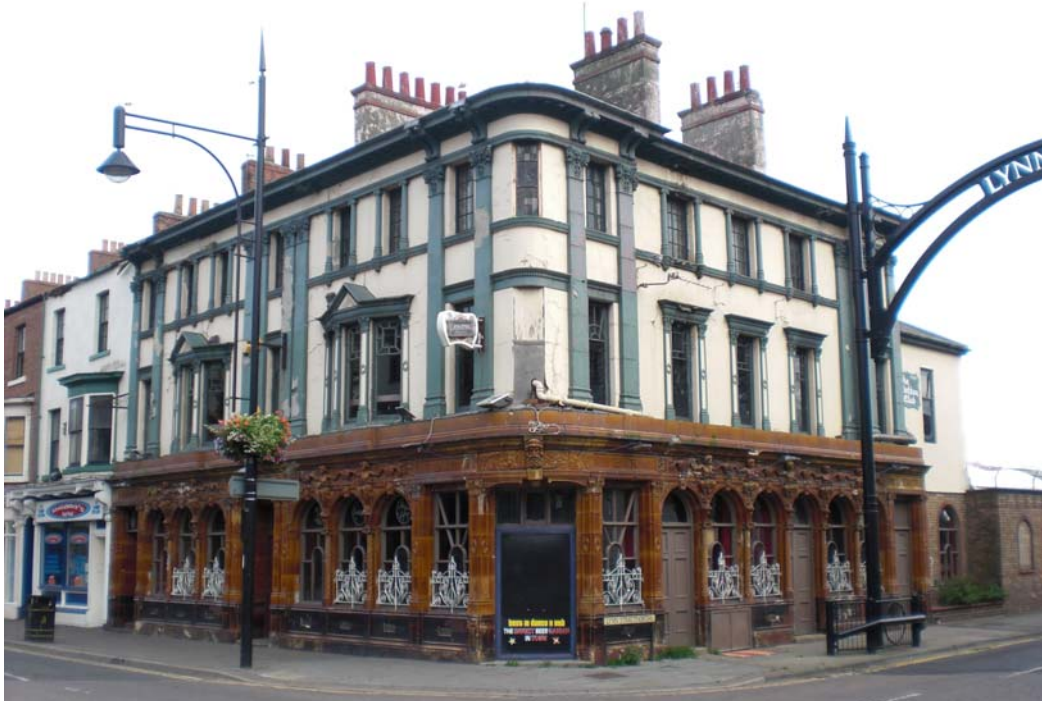
Shades, No. 16 Church Street

Condition *Very Bad*

It is believed that there may be structural problems in the upper floors of the building. Alongside the internal issues the exterior of the property has not been maintained. As a result the faience has deteriorated with parts breaking off. The Local Authority has been in contact with the owner regarding the external condition of the building after concerns that it may be endangering public safety. Vegetation can be seen growing in the guttering and much of the render to the upper floors is cracked with paint work peeling off. Formal action by the Local Authority using the powers it has available relating to listed buildings has been initiated to seek protection of the building and re-use.

Suitable future uses for the building could be to continue the existing use in a restored building or commercial uses similar to those found elsewhere in Church Street.

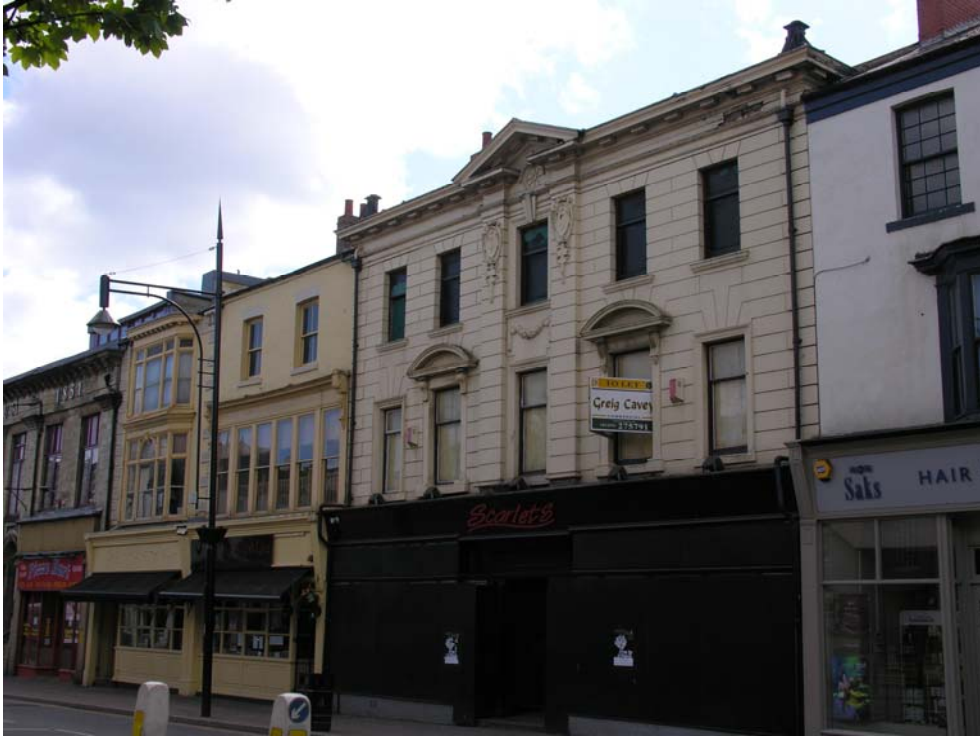
22 & 23 Church Street

Condition *Poor*

It appears to be sound and secure but there are signs of deterioration to the exterior of the property. The longer the building remains empty the more likely it will be that it continues to decline. Further to this the accumulation of vacant buildings within conservation areas, such as Church Street is experiencing, can have a negative impact on the area as a whole.

Suitable future uses for the building could be to continue the existing use in a restored building or commercial uses similar to those found elsewhere in Church Street.

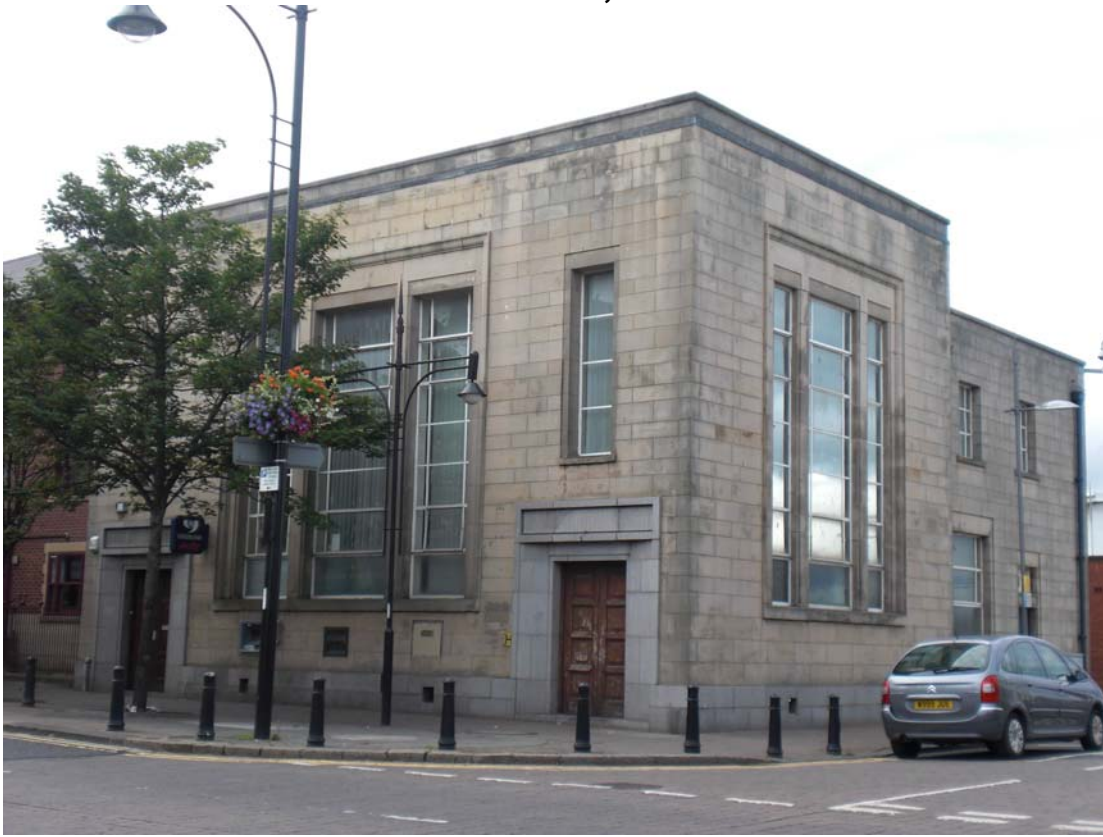
Former Yorkshire Bank, 65 Church Street

Condition *Poor*

Its current condition is poor and with the building showing little sign of being maintained on a regular basis. Cracking to the exterior of the property could be an indication that there are structural issues with the building. There is not a long term plan for the re-use of the property. The longer the property remains empty the more likely it will be that it deteriorates. Further to this the accumulation of vacant buildings within conservation areas, such as Church Street is experiencing, can have a negative impact on the area as a whole.

Previous uses of the building i.e. banking and those approved through the planning system (antiques centre and art gallery or general retail) would be acceptable. Alternatively the structure may be used for a commercial use similar to those found in the vicinity.

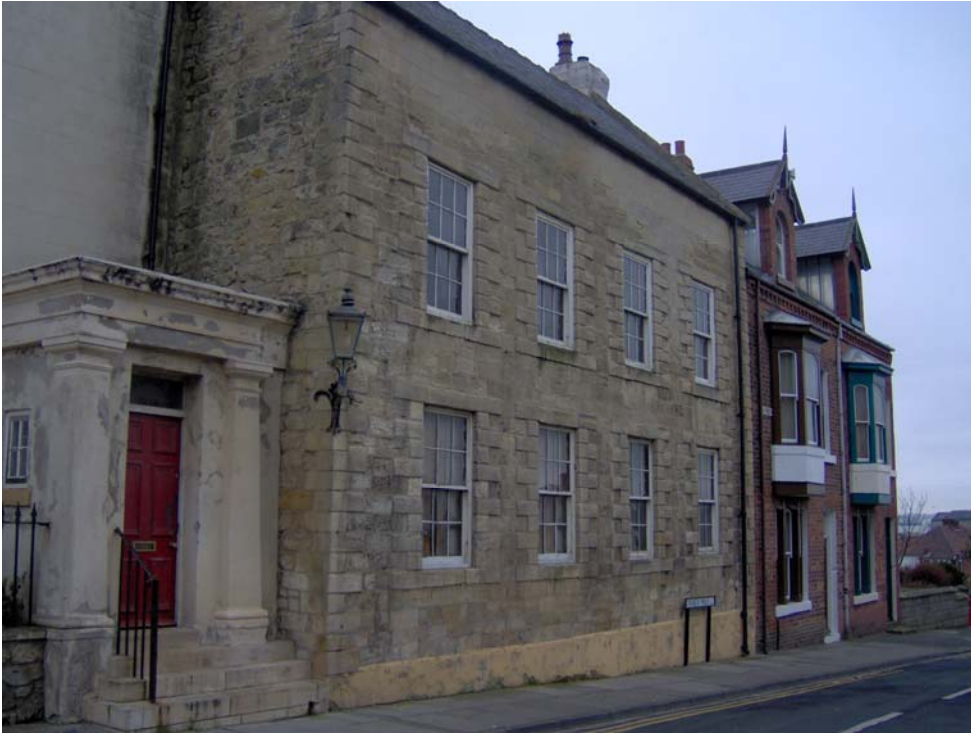
Former Conservative Club, Church Walk

Condition *Fair*

A change of ownership has occurred with the new owners implementing a scheme of alterations to the building (based on the consents detailed) to create improved kitchen and toilet facilities and greater utilisation of the building internally. As part of the scheme, work to the building is to be undertaken to address the backlog of maintenance, including render repairs, replacement of guttering and downpipes, repairs to windows and decoration. The intention is to still use the building as a social club as before, but to extend the use to wedding receptions, training events and conferences.

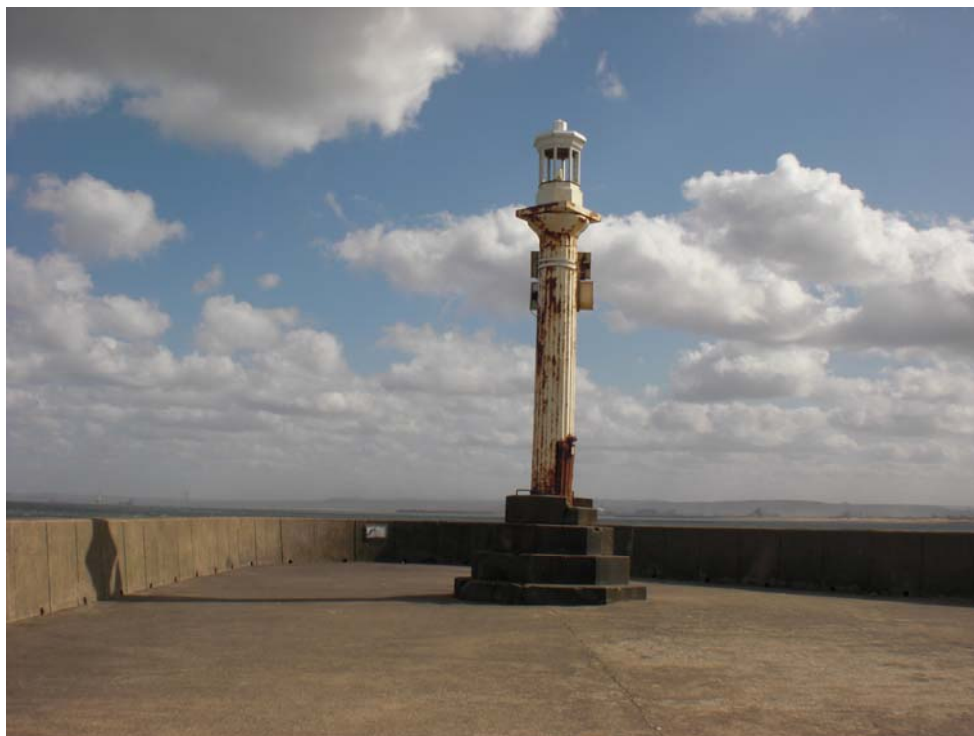
Beacon Tower at East End of North Pier of West Harbour

Condition *Poor*

The nature of the structure means that it is isolated and not readily accessible. The light does not appear to be maintained and shows signs of deterioration in the form of rusting to the main column. The sandstone plinth is also in a poor state of repair with the edges of the stonework badly damaged.

Due to the remote location of this listed building and with no formal, regular maintenance in place it would appear that the structure will continue to slowly deteriorate.

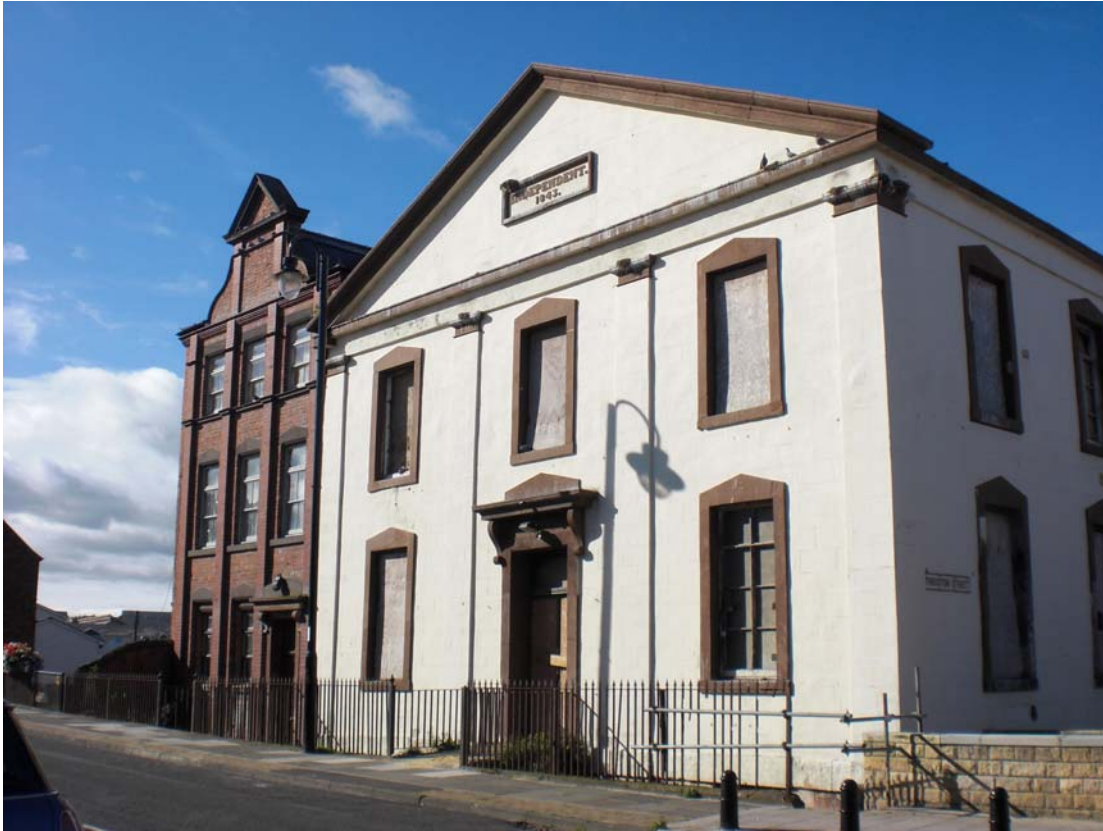
Former Durham Street United Reformed Church and Sunday School

Condition *Poor*

Works to the Church however have been sporadic. Some of the external works have been completed consisting of window replacement and the creation of new window openings as part of the consent. The internal conversion works to form the apartments is largely incomplete. However the ownership of the building has recently changed. The Church will still be vulnerable and its future uncertain until the intentions of the new owner are clear and the outstanding consent fully implemented with all the apartments largely occupied.

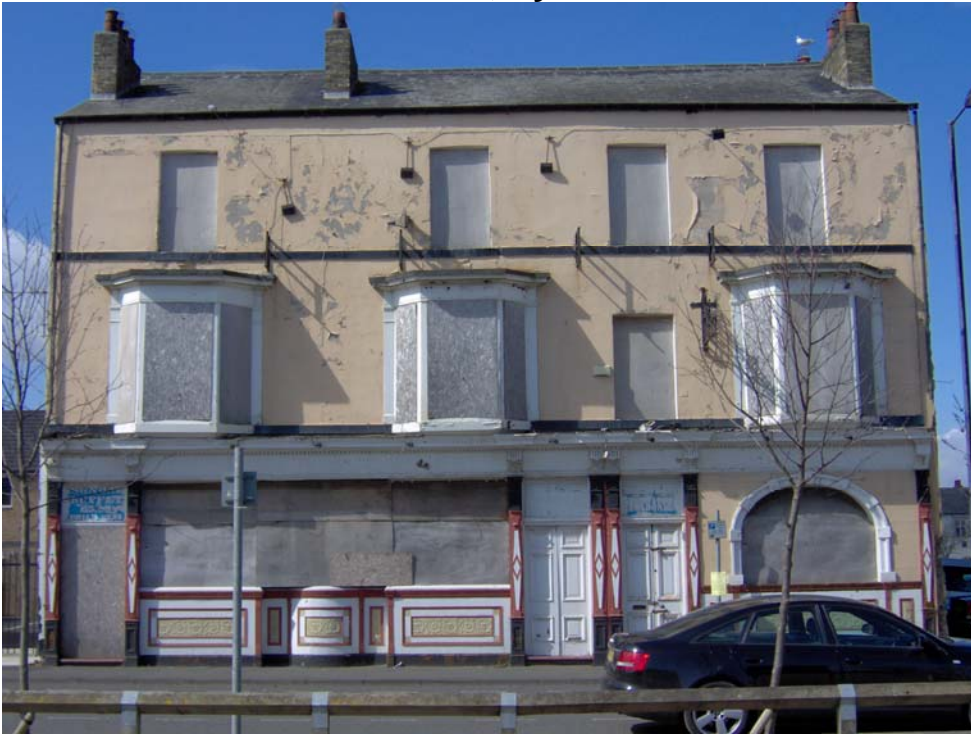
Market Hotel, Lynn Street

Condition *Poor*

Despite being vacant for a number of years the building is secure and is considered to be in a reasonable state of repair.

All of the windows have been boarded up to ensure that the building is watertight and secure. The property is rendered but this has been removed from the elevation facing Surtees Street leaving the brickwork exposed after an area of render was deemed to be of concern. To the front of the property the faience has been painted but this has begun to peel off revealing the tiles below. Although the tiling appears to be in good condition, with minor repairs required, the peeling paintwork is unsightly.

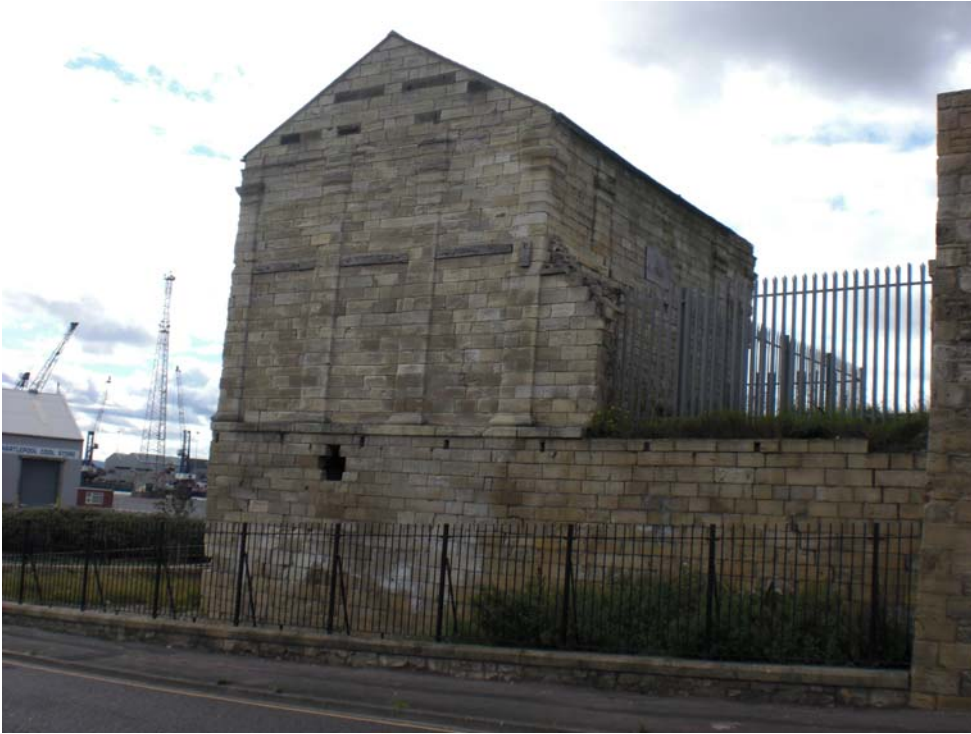
Throston Engine House, Old Cemetery Road

Condition *Very Bad*

The Throston Engine House is located on an isolated site at the end of a defunct railway line from Durham, with very little in the way of surrounding supporting development. Its physical isolation has been a discouragement to any potential re-use of the building.

A long term structural crack evident on the south-east elevation has widened, necessitating a supporting scaffold to the east corner of the building to prevent a potential collapse. On the opposite corner of the building vandalism damage (consisting of area stonework being removed) has been re-built in a concrete block. Overall the structural integrity of the building is under threat.

The ownership of the building has changed recently. Until the intention of the new owners becomes clear and a firm commitment is made to addressing the structural condition of the building, its exposure to the weather and lack of complete security, places the long term future of this listed building in doubt.

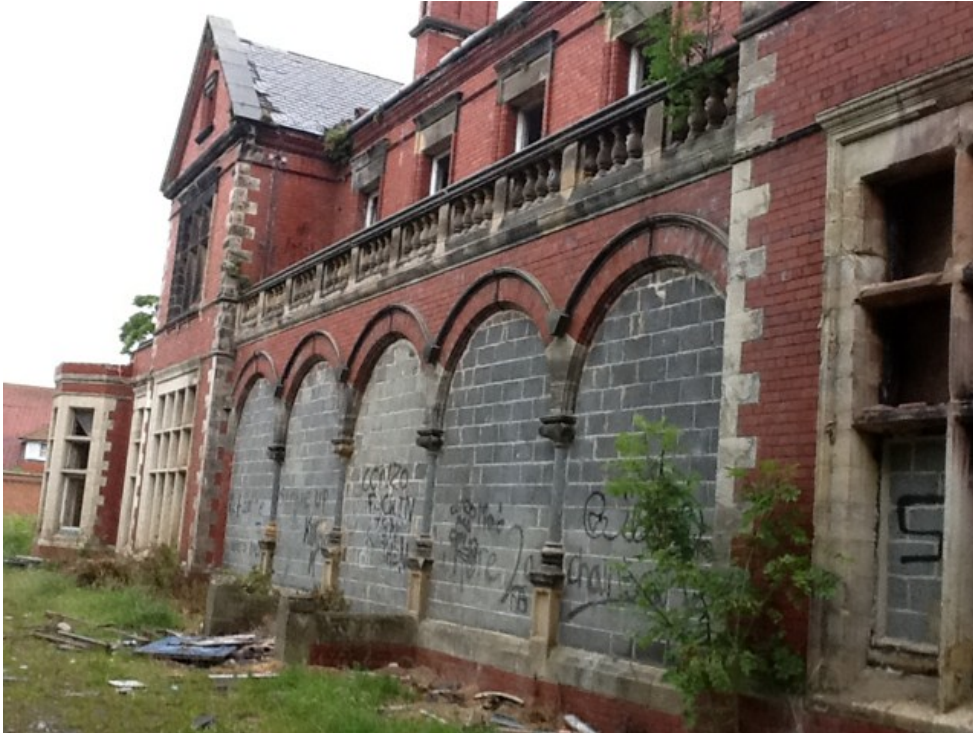
Tunstall Court, The Parade

Condition *Very Bad*

It has been subject to a number of arson attacks along with vandalism both inside and outside the building. An area to the rear of the building (the original ballroom) has been taken down after a fire rendered it unsafe. Efforts have been made to secure the building by putting block work in openings and boarding up windows however it remains vulnerable and continues to be the focus of anti-social behaviour.
