HERITAGE AT RISK IN HARTLEPOOL 2013

State of the historic environment in Hartlepool at a glance

This document was agreed by Planning Committee on 25th September 2013. It is the Council's intention to review this list annually to ensure that the information contained is correct and an accurate reflection of Heritage at Risk in Hartlepool.

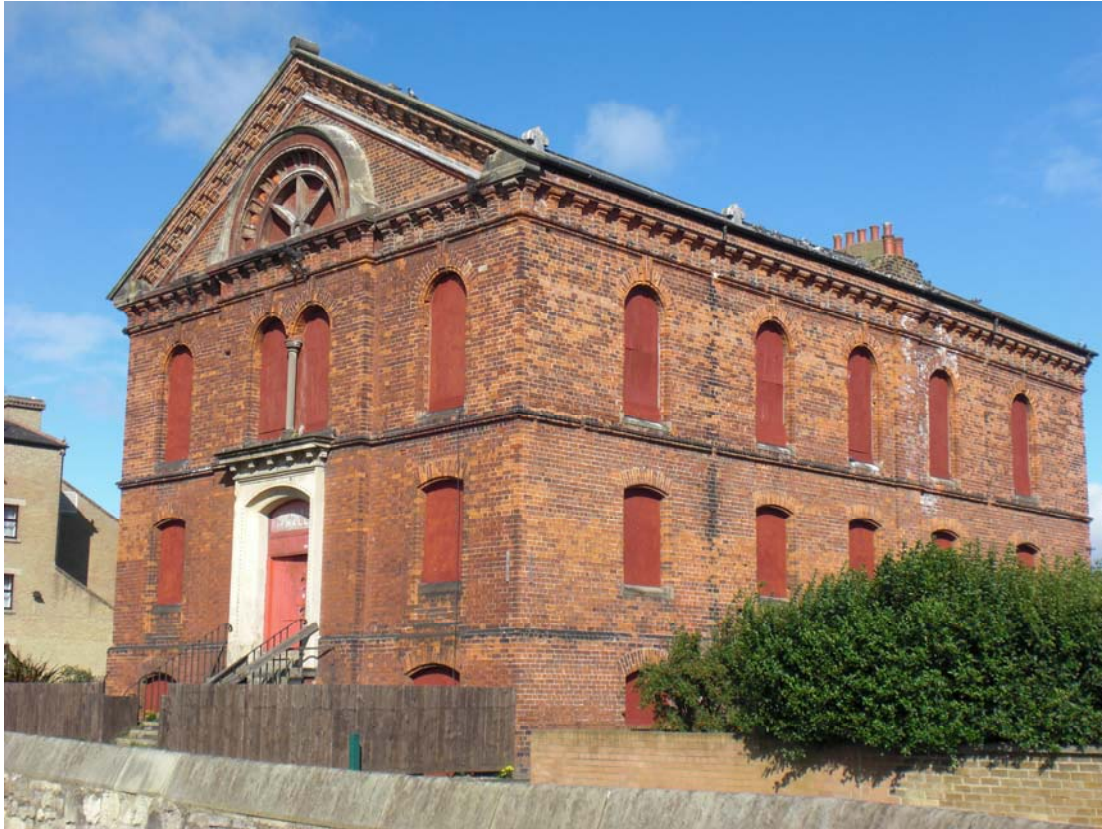
Morison Hall, Church Close

Condition *Poor*

Priority *C (Slow decay, no solution agreed)*

The external fabric of the property is in a reasonable condition. A grant was provided in 1998 for re-roofing and structural works. The building has been secured with windows and doors boarded to prevent entry. Recent internal inspections suggest that little maintenance of the building has taken place since it became vacant. There is some limited damage to the interior from the fire but the property appears, for the most part, to be sound.

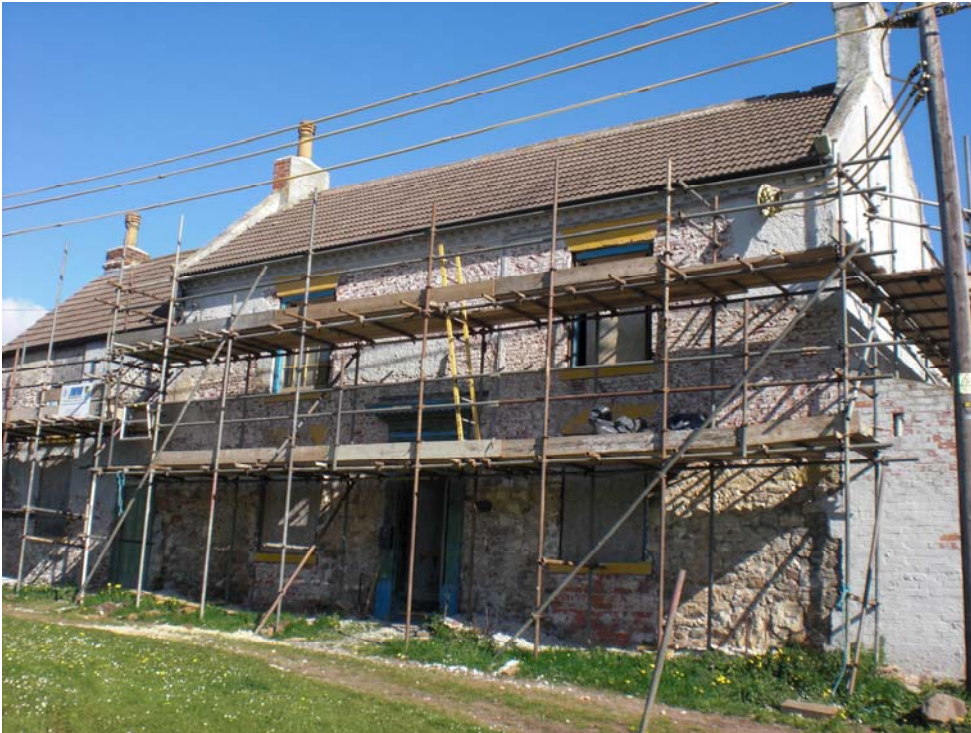
Manor House Farm, Dalton Piercy Village

Condition *Poor*

Priority *F (Repair scheme in progress)*

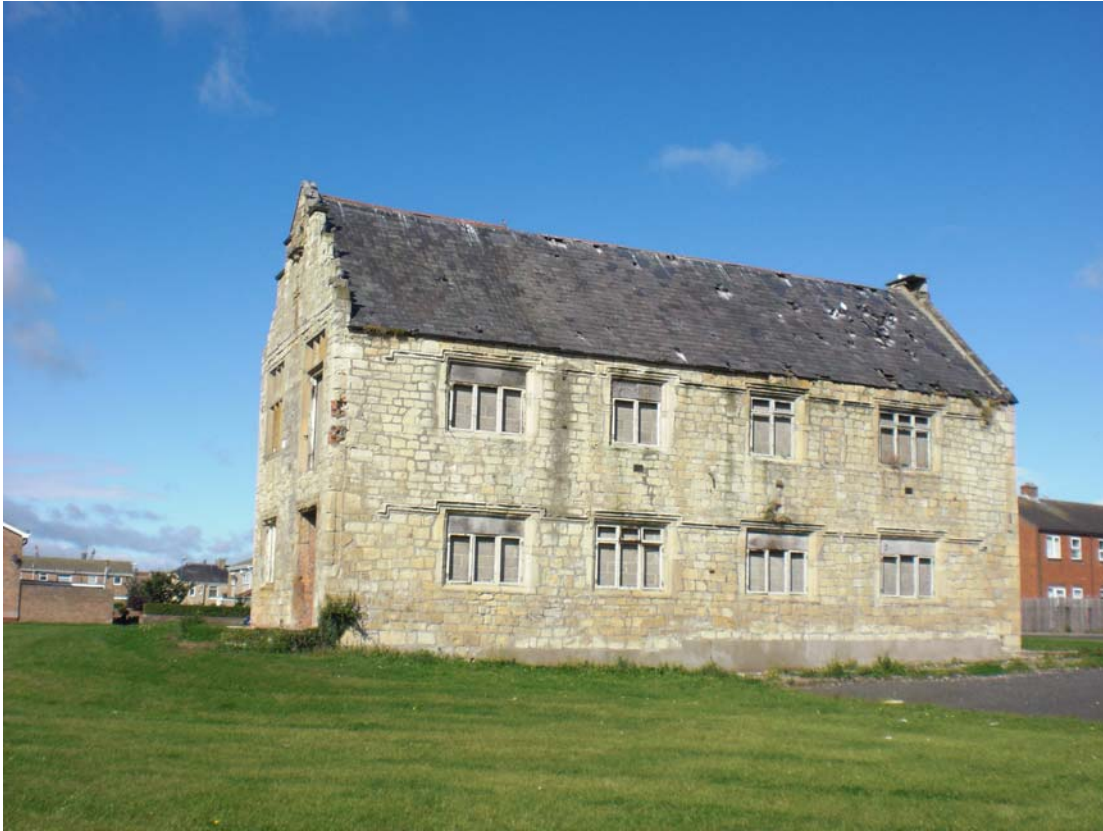
Friarage Manor House, Friar Street

Condition *Poor*

Priority *C (Slow decay no solution agreed)*

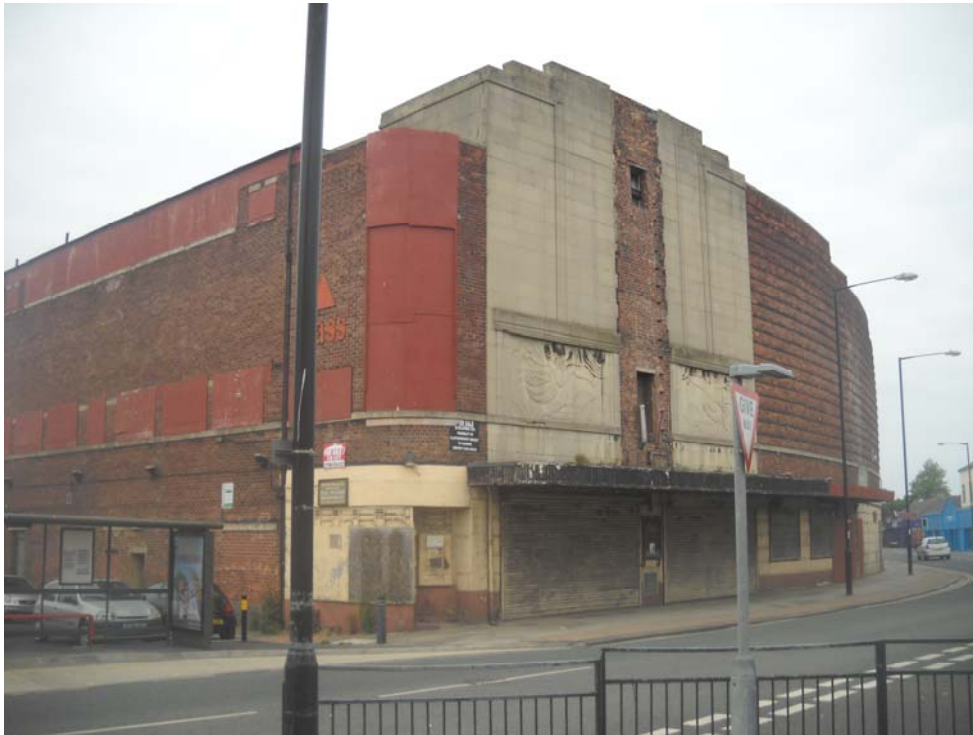
Former Odeon Cinema and 81 – 87 Raby Road

Condition *Poor*

Priority *C (Slow decay, no solution agreed)*

As with so many cinemas from this date it is no longer in operation. A new use was found temporarily as a night-club, but this too has now ceased and the adjoining shop units are empty.
