NEIGHBOURHOOD SERVICES SCRUTINY FORUM AGENDA

Investigation into the Possible Environmental Impacts of Dust Deposits on the Headland and Surrounding Areas

envoy report

VAN DALEN (HARTLEPOOL) LTD, IRVINES QUAY, HARTLEPOOL, TS24 0UZ.

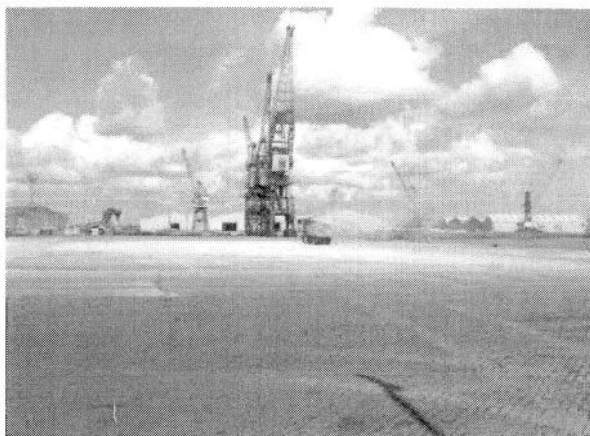
General Description: a naturally occurring magnesium silicate. Toxicity moderate by inhalation, EH40 WEL of 1mg/m³ in air. Between 11:00 – 12:45 a road-sweeper was deployed to the northwest of the site to clear an area of white powder (presumed Talc). The cleaning operation liberated an unusual amount of particulates but, as the wind direction of

the plume was to the north the event was unlikely to have had an impact on ambient or personnel monitoring pumps.

Ability to affect study: LOW, although noted, wind direction carried material away from monitors.

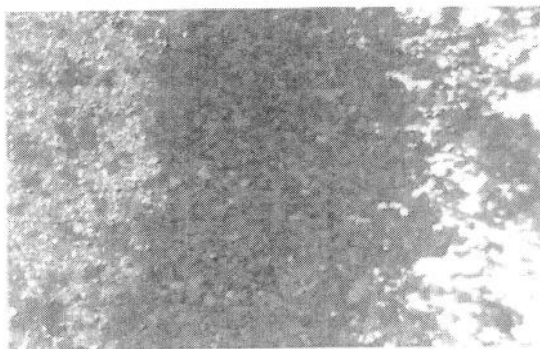
Slide Example:

Sample collected 29.2.07 from Bow Window, 3 Town Wall.

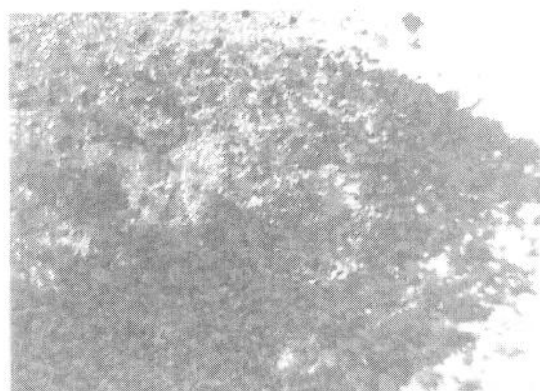
Slide Example:

Rust deposits collected 02.5.07 from old stock material.

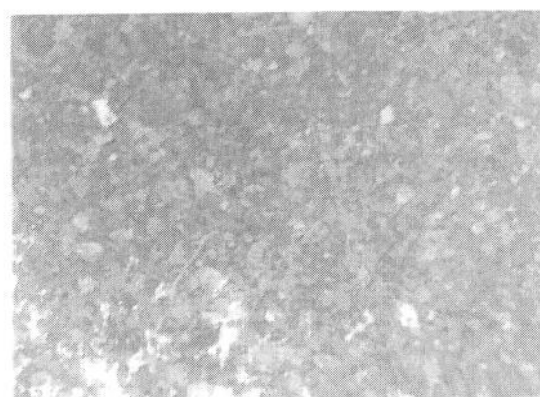
Slide Example:

Sample of accumulated rutile sand from site collected 02.5.07

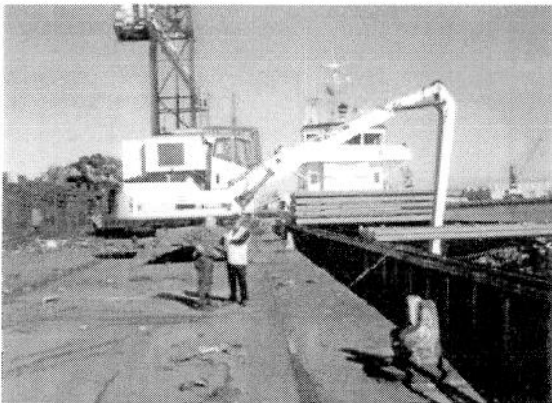
Slide 3:

Site Terex in operation to level ship. No visual evidence of dust.

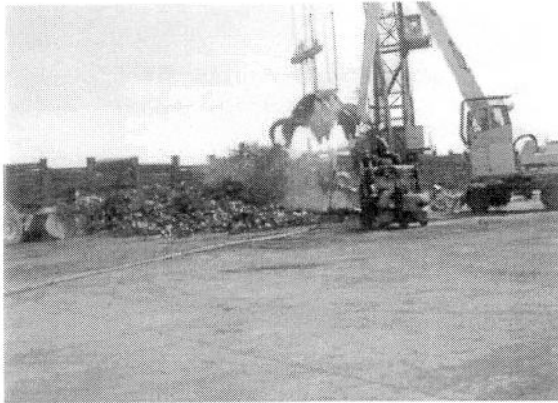
Slide 4:

On-site, dust becomes more slightly more significant as load collection works towards the base of the pile.

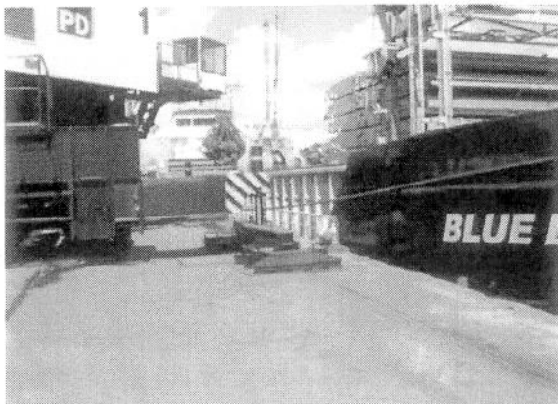
Slide 5:

However, suppression techniques appear successful in suppressing emissions during loading.

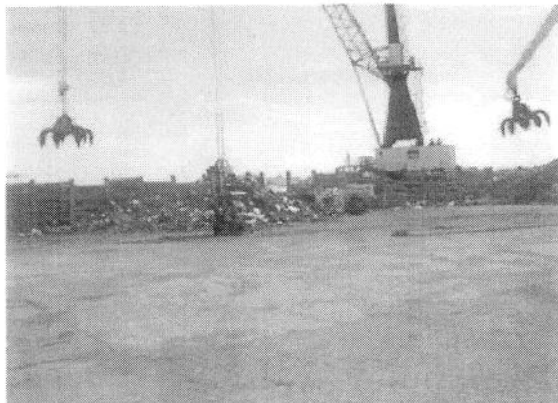
Slide 6:

A point is reached when optimal saturation by water spray is reached. Subsequent crane loads do not produce particulates.

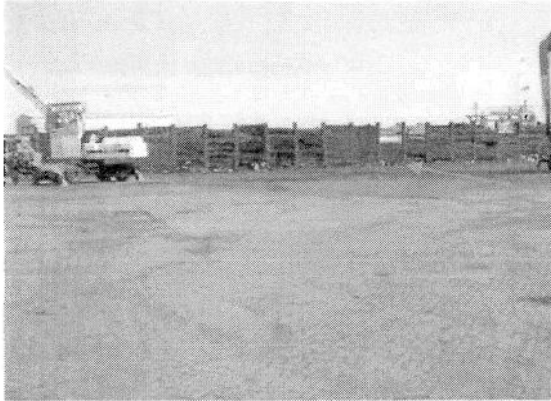
Slide 7:

End of old stockpile. In addition note accumulations of rutile sand (darker material highlighted).

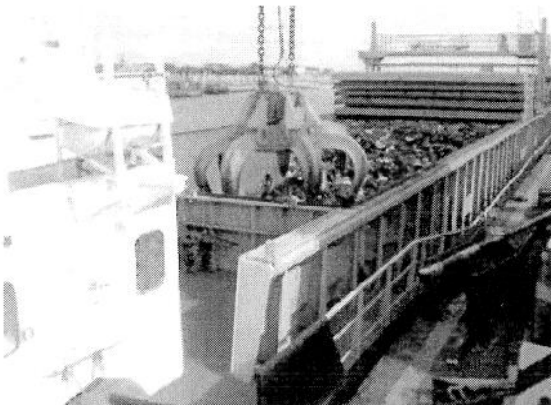
Slide 8:

Deposit of new stockpile. No dust noted.
