Hart

<u>Building</u>	<u>Page</u>
Chaplains Well, Butts Lane	50
Outbuilding, Beckwood House, Front Street	51
Hart Farm, Front Street including Out Buildings	52
Home Farm Barns, Stables and Old Farm House, Front Street	53
The White Hart PH, Front Street	54
Former farm buildings and agricultural buildings at Hart Pastures	55
Chare Walls, approach to St Mary Magdalene Church	56

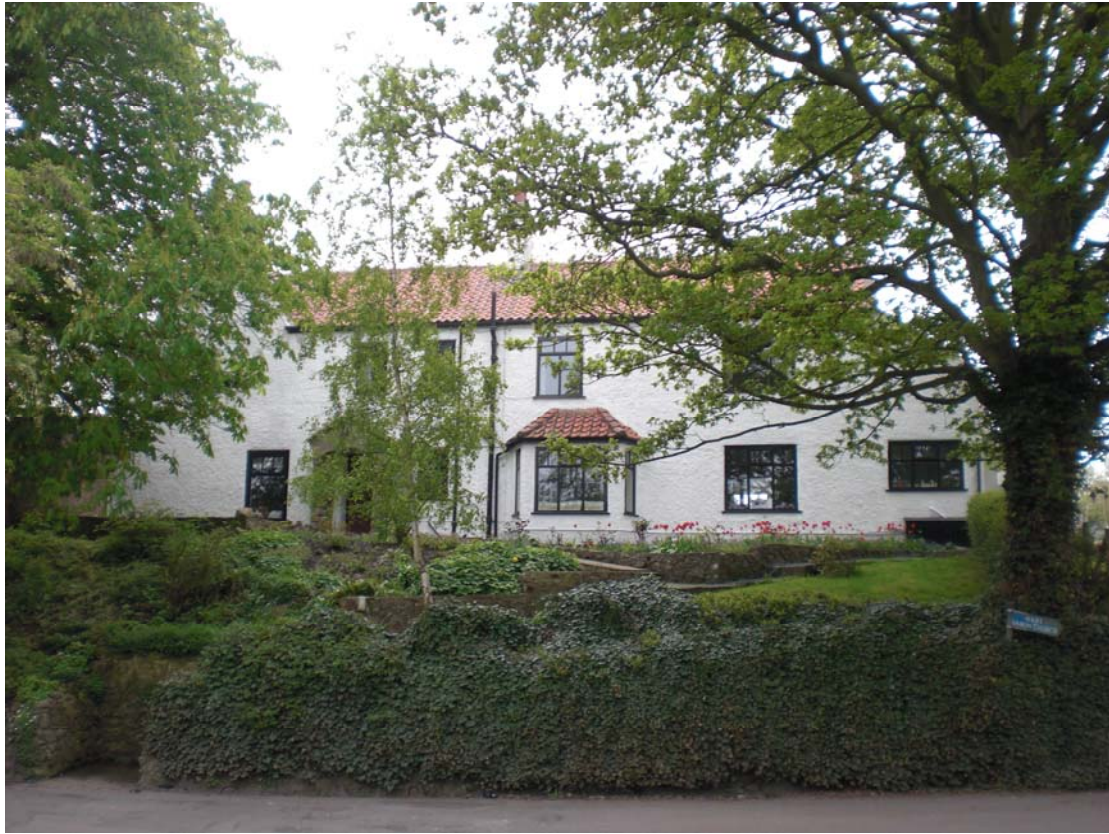
Name Chaplains Well, Butts Lane, Hart

This property was originally the Vicarage to St Mary Magdalene Church. There are elements of 18th century buildings and possibly earlier. A composite of gables, varying in size and further extensions on several faces of the 'L' shaped property, aptly express its age. The narrow rectangular shape of the middle portion of the Old Vicarage is indicative of Medieval design; whether the property has retained any Medieval features is perhaps unlikely, but foundations dating back that far may still exist. Chaplain's Well forms the north wing of the property, and it is much more recent, probably 19th century in its current state. The entire structure is of stone and mortar, with the thicker walls of the Old Vicarage and its outbuildings in-filled with rubble.

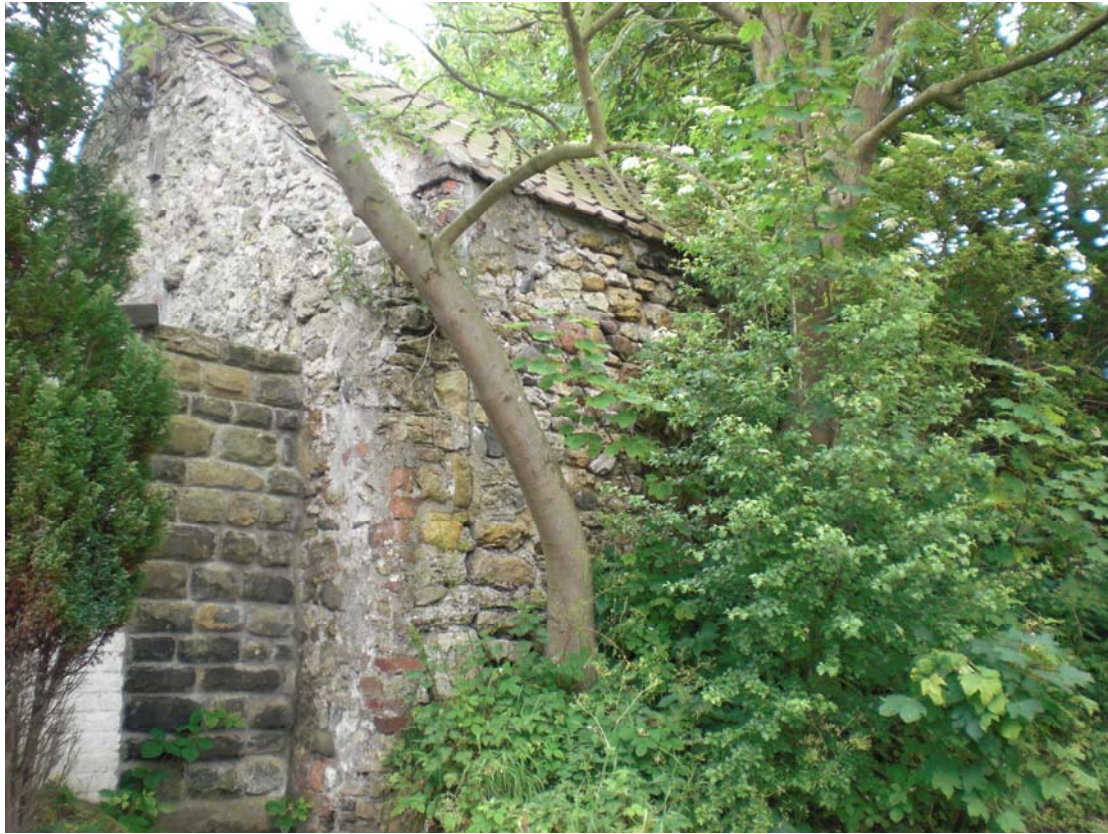
Name Outbuilding, Beckwood House, Front Street

This outhouse within the grounds of Beckwood House is the only remnant of the large farm estate that used to be situated this end of Front Street. Rubble and mortar have been used for the majority of this structure, topped with modern pantile. To its north elevation is a brick extension joined by a small moulded stone wall between the two. The original roof-line from previous structures is still visible on the stone building.

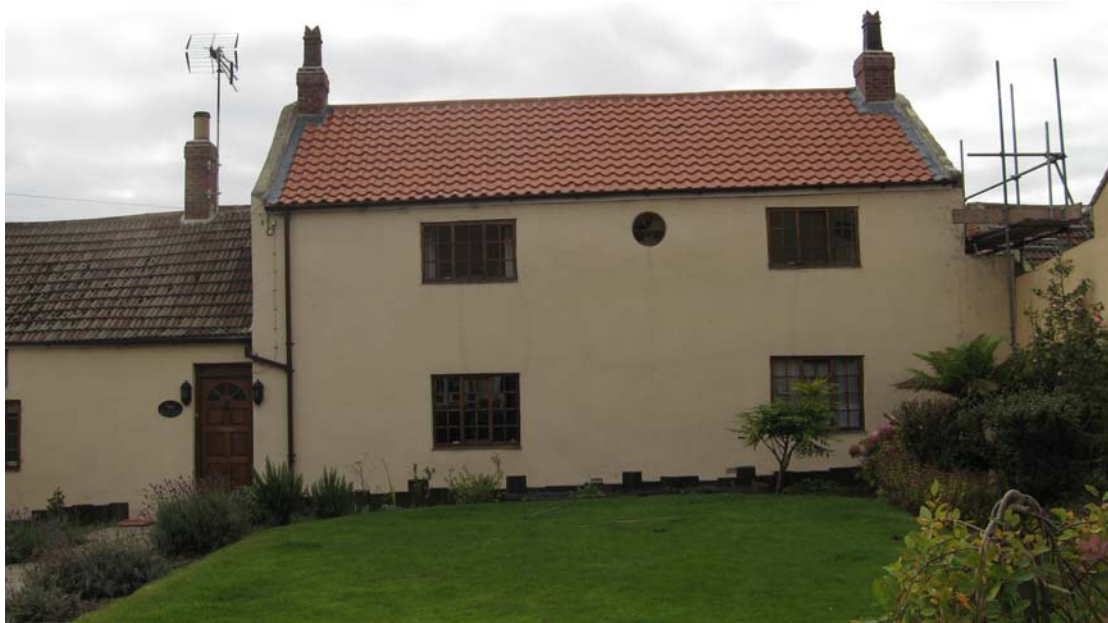
Name Hart Farm, Front Street inc out buildings

18th century whitewashed render, modern concrete tiled roof. Two storey with single storey wing with attic to east main block has two ground floor and two first floor horizontal sash windows with glazing bars, one central circular window with radial glazing bars to first floor. Rendered gable copings and two rendered gable end chimney stacks. Single storey wing has a four panel door to right with rectangular fanlight with central vertical glazing bar. One ground floor horizontal sash and one horizontal sash to attic.

To the rear of the property are a series of barns which appear to be contemporary with the main farmhouse. These are constructed in random rubble with pitched roofs over.

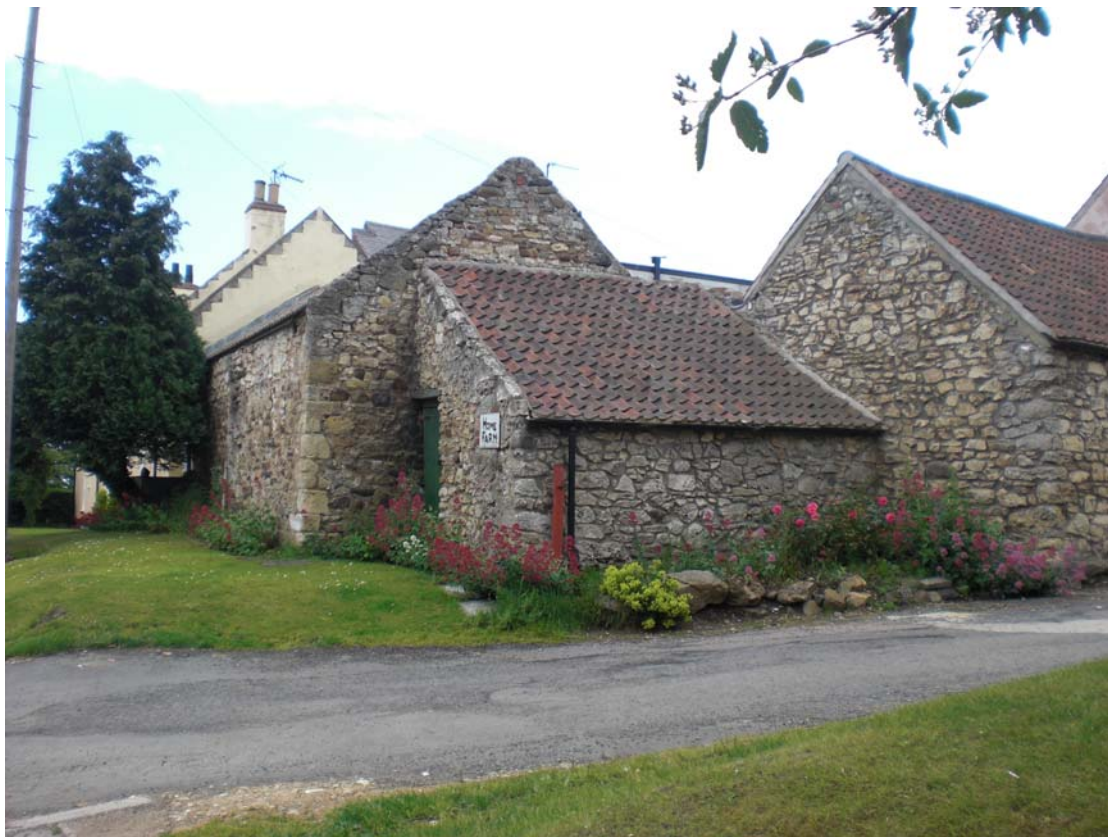
Name Home Farm Barns and Stables,
Front Street

The farm house is mid-late 18th century set back several metres.

To the rear of the property are a series of barns which appear to be contemporary with the main farmhouse. These are constructed in random rubble with pitched roofs over covered in pantiles and in some instances slate.

The buildings have been converted to provide facilities for a training centre. As a result modern doors and windows have been inserted into some of the openings in the barns.

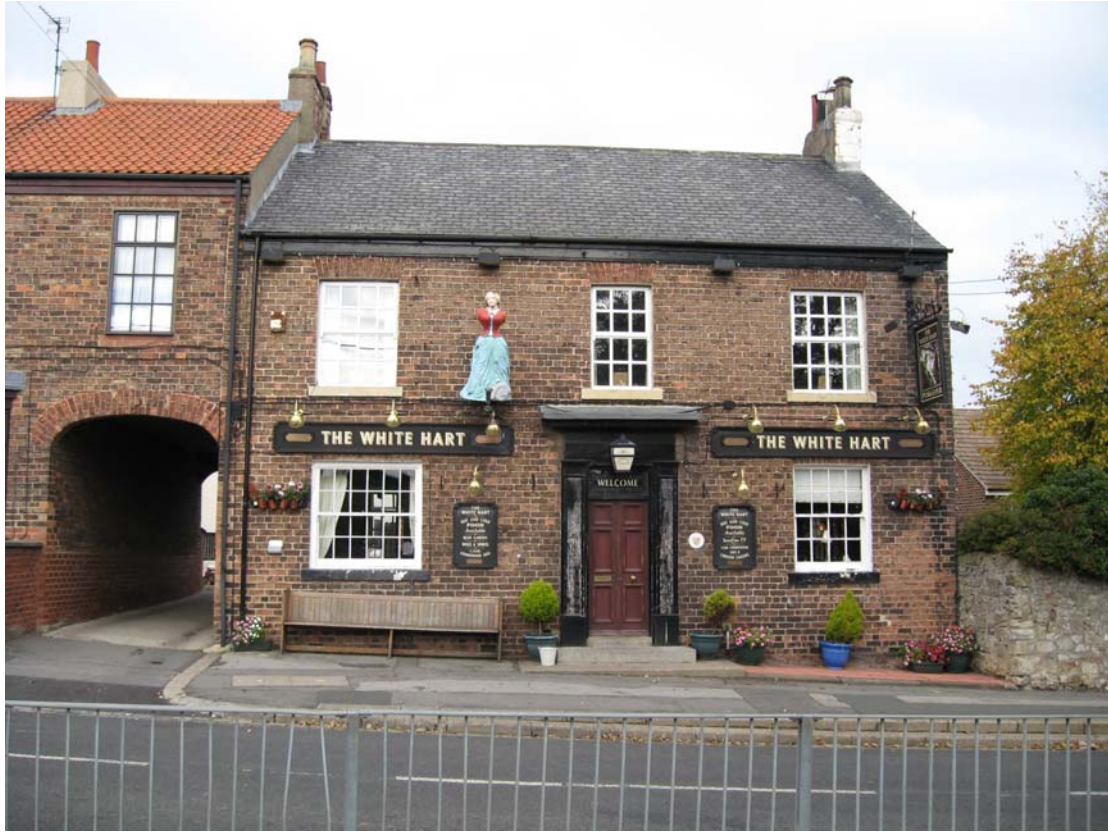
Name The White Hart PH, Front Street

The property appears to have been purposely constructed for use as an inn, but contains many of the features present in other residential buildings adjacent including brick voussoirs on the first floor windows. The windows themselves are multi-paned and both replacement casement and vertical sliding sashes.

The roof is made of Welsh slate, in keeping with the 19th century roofing style. Unlike the front, the gable end of the building has been completely rendered white, and had been extended and squared off towards the rear which has various adjoining outbuildings.

A ship figure head, locally attributed to the Rising Sun of Sunderland wrecked off the coast in 1861, is bracketed to the first floor wall frontage.

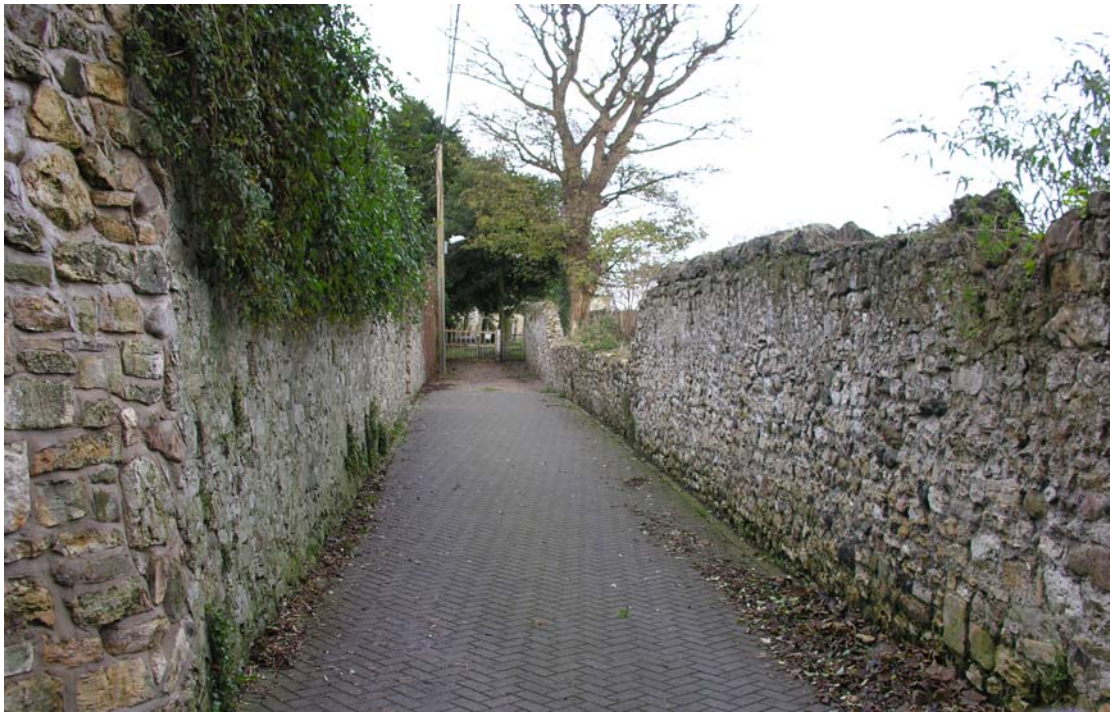
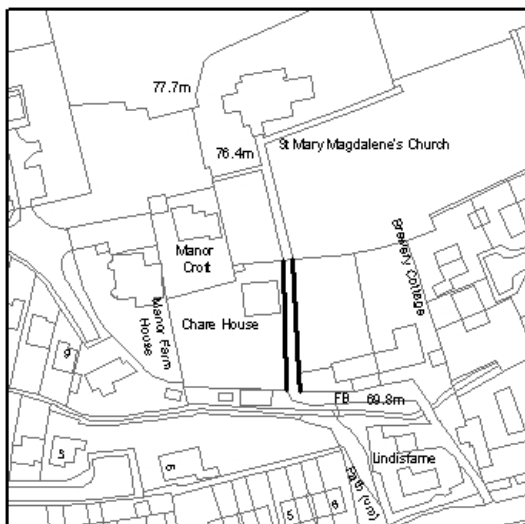
Name Chare Walls, approach to St Mary Magdalene Church

The walls either side of the approach to Hart Church are a heavily modified boundary wall, approx 2m in height spanning from the southern churchyard boundary to south boundary of Voltigeur Cottage, forming the east wall of the path known locally as 'The Chare'. Built of stone and rubble with mortar of varying ages, and one small entrance allowing access to Votigeur Cottage. The bottom half of the wall contains more moulded magnesian limestone blocks, steadily replaced by rubble towards the top, with a mixture of lime mortar and recent mortar/cement re-facing. The opposite wall is a similar age and originally surrounded the immediate land owned by the Manor House estate.
