Dalton Piercy and Rural Area

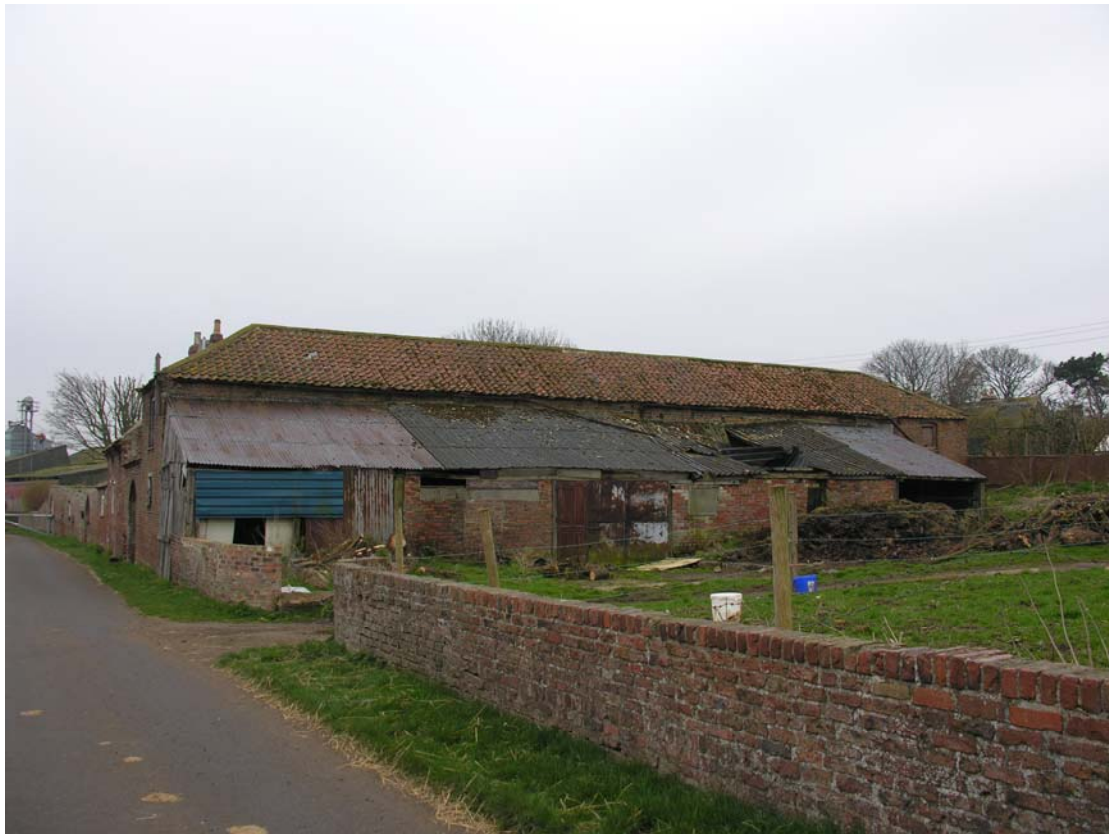
Farm outbuildings north of farmhouse and separate outbuildings east of Brierton Lane 120ft north of farmhouse. Farmhouse much altered and of reduced interest.

Rectangular range of farm outbuildings north of farmhouse including wall and gated openings to east side of farmhouse. Mid 18th century with later 19th century alterations. Both single and two storey. Hipped pantiled roofs with stone copings and kneelers. Moulded and stepped brick eaves. Separate outbuildings - late 18th or early 19th century in hand made brick with hipped pantile roof with stone copings and kneelers. Moulded corbels. Elliptical headed cart arch in south face.

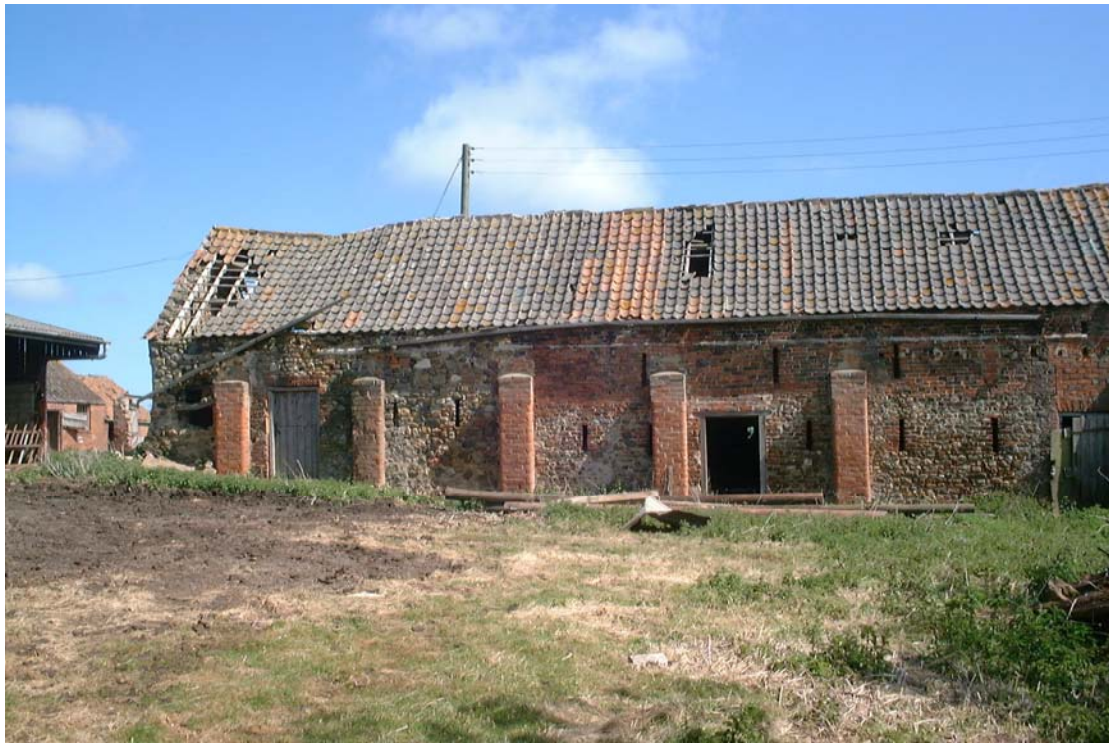
Located west of A19. Late 17th to early 18th century barn. West end constructed in random rubble (mostly cobbles) which continues on the south elevation with a brick lift above. The rest of the barn is constructed in brick dating from the late 18th century with buttressing added in the 19th century. Roof in clay pantiles. Random rubble construction suggests an early two storey rubble stone farmhouse or longhouse with a single storey at the east end. Photographs indicate a possible cross passage which suggests a likely early farmhouse use.

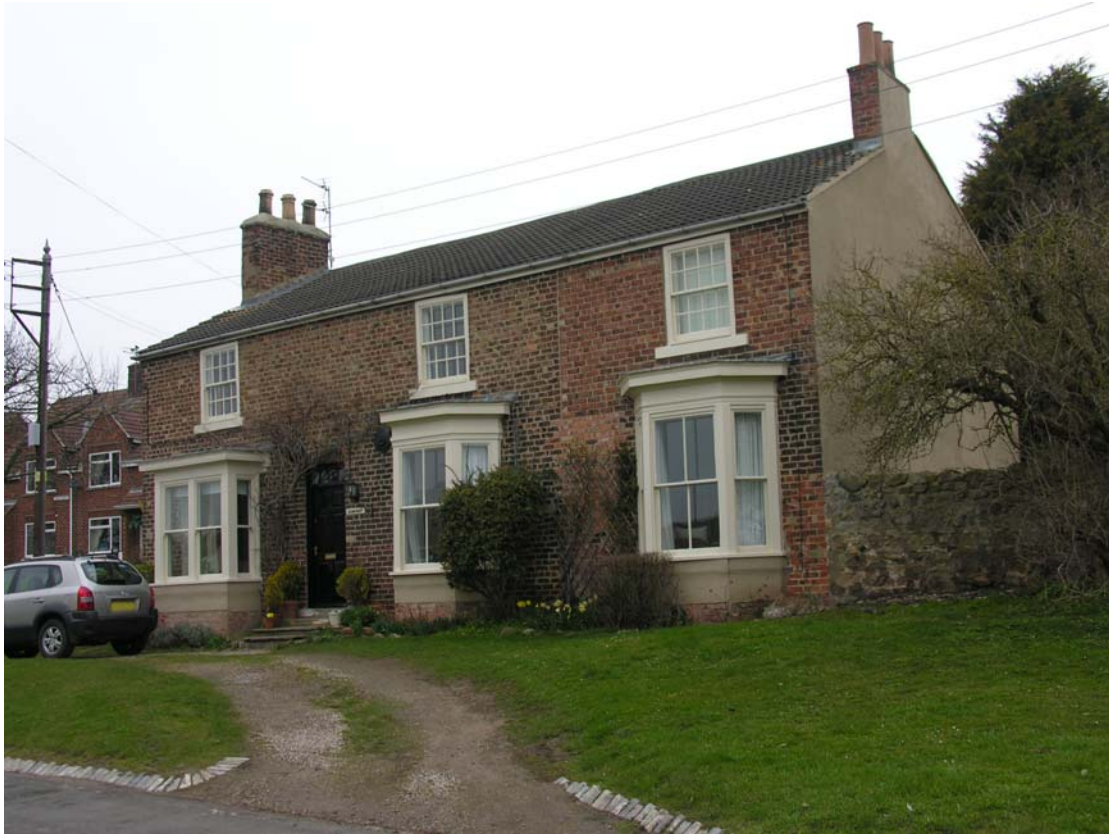
Late 18th or early 19th century house with adjoining mid 19th century house addition to form a short terrace now occupied as one house. Earlier house of three bays with symmetrical front elevation consisting of centrally located front door flanked by canted bay to right and square bay to left side. Immediately above bays at the first floor are two 8 over 8 sash windows. Sash window also to west side elevation. Replacement panelled door and frame.

Later 19th century house, single fronted with canted bay window to ground floor and 8 over 8 first floor sash window above. Brick construction, rendered side walls with later concrete tiled roof. Scar left in brickwork of previous front door to this house.

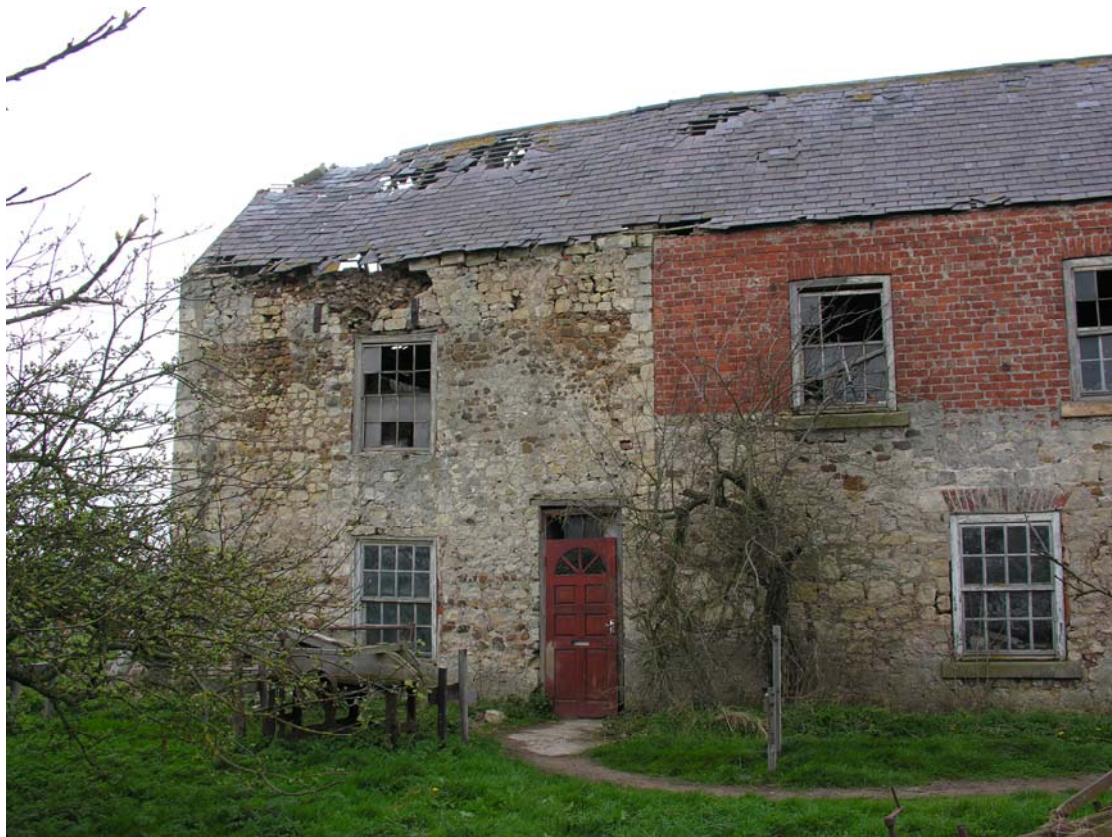
17th century or earlier 2 bay farmhouse with brick first floor addition to east side over earlier stone built outbuilding to give building of 4 bays. Built in a roughly coursed random rubble lime stone with cobble stone infill either in courses or complete panels with later first floor addition to east in a mid to late 19th century brick. Dressed stone quoins to all corners. To main south elevation 5no (3 to first floor and 2 to ground floor) 8 over 8 sash windows. Evidence in stonework of lift above first floor window. Original door frame and fanlight with glazing (divided into 4 panes). To north elevation 1no high level "yorkshire light" horizontal sliding sash window with bricked ground floor window opening to original farmhouse. East gable with scar of earlier two storey building with steeply sloping roof. West gable in the same stone construction as south elevation but in partial collapse around chimney stack. Roof in slate. Later 18th century farm buildings to north behind later 19th and 20th century buildings. Built in roughly square limestone blocks and roughly coursed with quoins to corners.
