CHURCH STREET CONSERVATION AREA

Visual Assessment

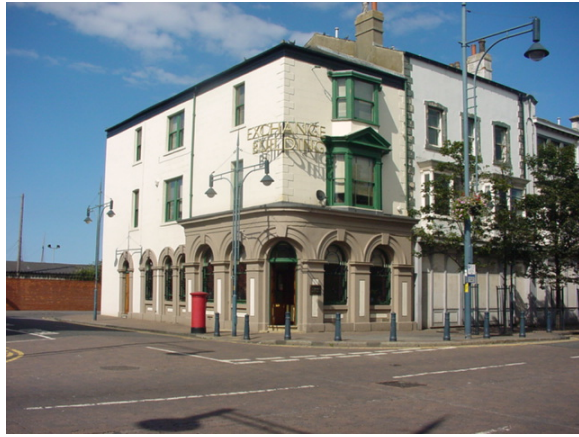
3. The buildings in Church Street generally are three storeys, with additional space in the attic where dormers to the roof provide light and ventilation. Buildings have a strong vertical emphasis with pitched roofs exclusively finished in slate. Traditional timber sash windows add to the vertical emphasis. Walling is constructed in brickwork, often rendered and painted. Bay windows of the Victorian canted type and the Edwardian square type have been added at first floor level, sometimes replacing an earlier sash window. Of particular note are the traditional shop fronts with many original examples surviving. These often have highly decorative features such as moulded corbels above pilasters, cornice moulding to fascias and decorative mullions and transoms.

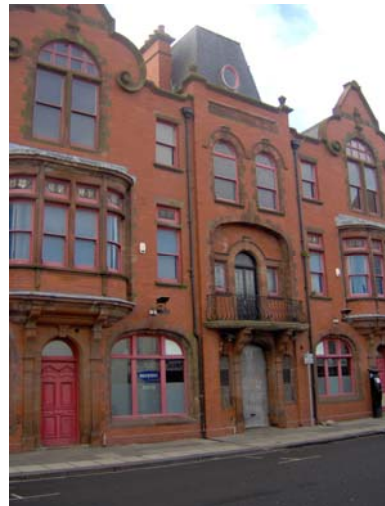
- Whitby Street – The Constitutional Club is the most significant empty property in Whitby Street. The Constitutional Club (which is listed) has figured before as one of the problematic larger vacant buildings. It appears to be temporarily closed, as furniture and equipment is still inside and no for sale boards are displayed on the building. 9 Whitby St/3 Jersey St is a shop property (with a flat above) opposite the Club, which has been vacant long term. 10 Whitby St is also vacant but from details on the property appears about to be let. Just outside the conservation area is the Hard Rock Café (formerly the Post Office) like the Constitutional Club a listed building and one of the problematic larger vacant buildings which have figured before.

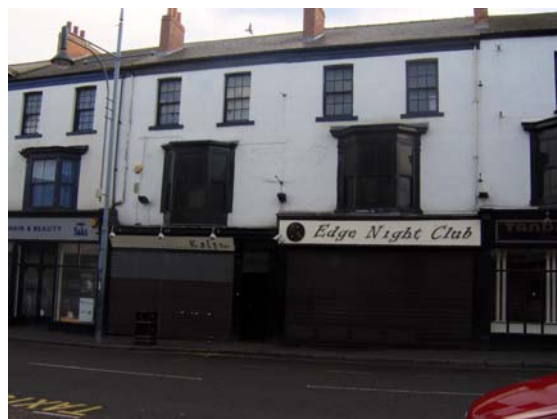
- Integrating a roller shutter into an existing shop front can be difficult, possibly disrupting its design and appearance, particularly so if the frontage is a highly detailed original example. External shutters may in some cases be the only alternative if owners' understandable concerns to protect their properties are to be addressed and the quality of the shop front preserved. However such an approach would have a detrimental effect upon the character of Church Street as a conservation area. Investigation of alternative approaches to help owners protect their properties rather than adopting external shutters would both protect the character of the

4. **Shop front shutters and advertising** – As indicated in the document the integration of roller shutters into the overall shop front design or investigation of an alternative means of protecting shop front glass from damage, can enhance the character of individual buildings and the wider appearance of Church Street. The type, design and detail of advertisements to buildings and shop fronts can equally have a positive impact on the appearance of Church Street. Some advice on the issues raised above already exists in the form of a “Shop Front Design Guide “ leaflet produced by the Council in conjunction with the New Deal for the Communities Partnership, which addresses some of the issues of roller shutters, a palette of paint colours for shop fronts and signage. Alongside this, advice is provided in the Local Plan in the form of a Supplementary Guidance Note covering shop front design and advertisements. A leaflet could be produced for owners in Church Street to emphasise some of the issues like shop front signs and advertisements. A good recent example of what is appropriate and what can be achieved is at the former Central Buildings on Church Street where a hand painted shop sign and appropriate choice of colours for the redecorated shop front has added to the quality of the surrounding area.

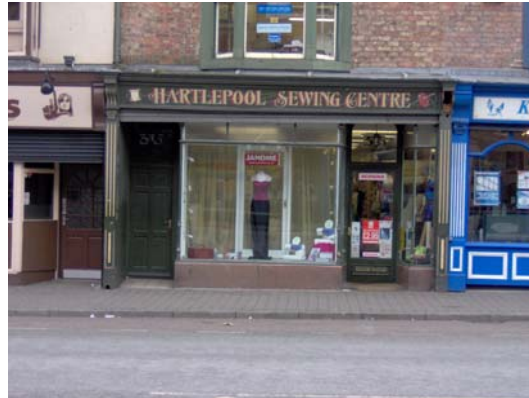
6. **Maintenance of Street Environmental Works** – Church Street was subject to extensive street environmental works as part of the strategy to improve the appearance and increase the confidence of owners. This investment has mostly survived very well. The main exception to this is the area forming Church Square around Christ Church and to the side of Municipal Buildings. This scheme has not stood up to the wear and tear of what is still a busy street, with areas of the surfacing material failing on a regular basis. The area is likely to be subject to a further scheme to address these emerging problems. The other issue for concern is the maintenance of street furniture installed in Church Street. The furniture consists of mostly bollards, lighting columns, a canopy over 49 to 53 and 56 to 58 Church St and entrance features over Whitby Street, Lynn Street and the Station Approach. The street furniture appears not to have been decorated since installation, with the paint now oxidised. A relatively low cost scheme to decorate this furniture would have an immediate impact, but needs to be undertaken as part of an approach to owners to also consider decorating their properties as discussed above. The surfacing material to Church St and trees continue to make a positive contribution to Church Street.
