STRANTON CONSERVATION AREA

VISUAL ASSESSMENT

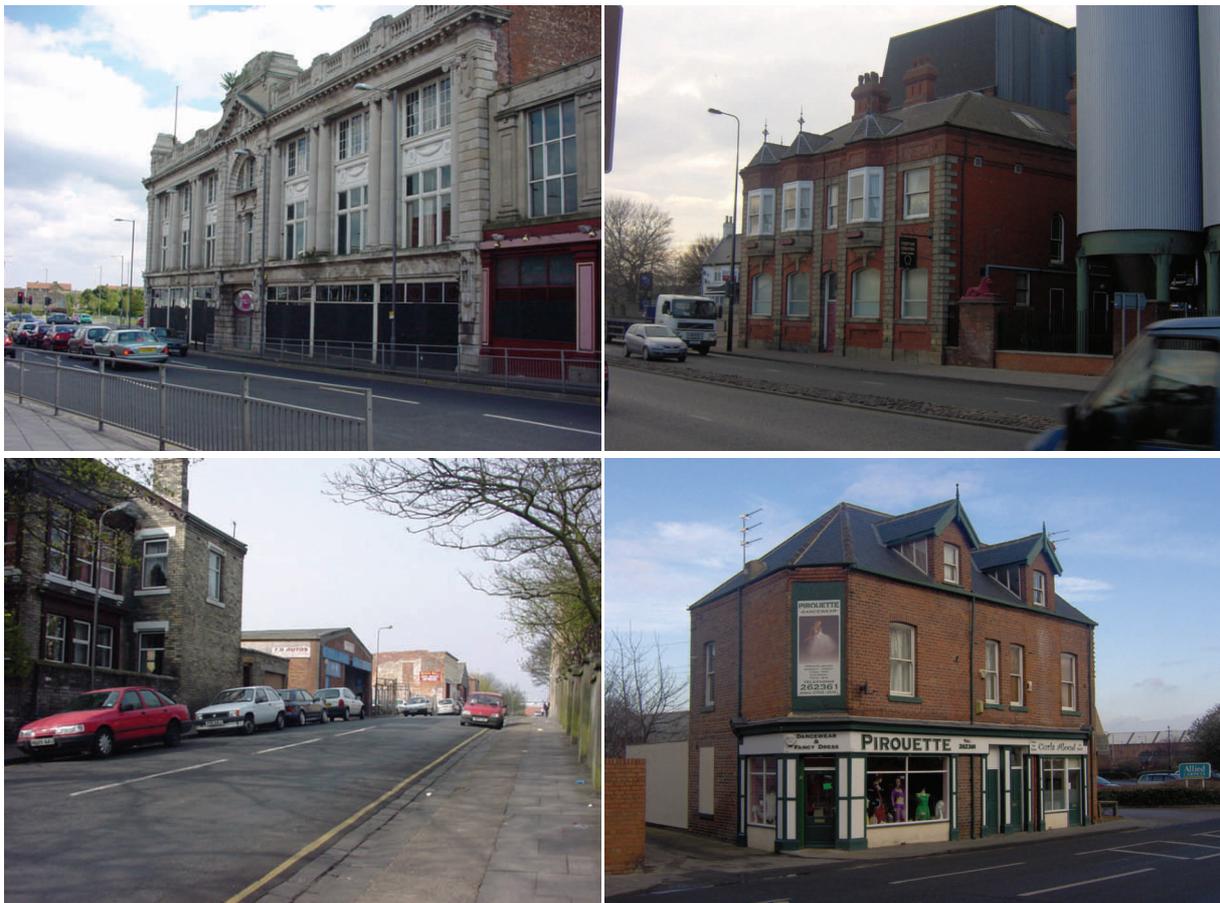
Photographs showing boundaries of conservation area (clockwise from top-left) Park Road (north), A689 (east), Waldon Street (west) and Burn Road (south).

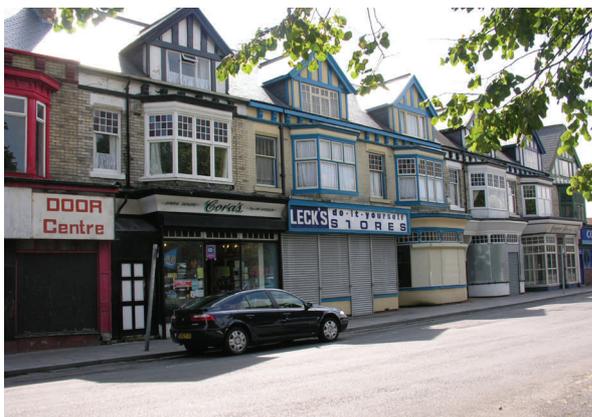
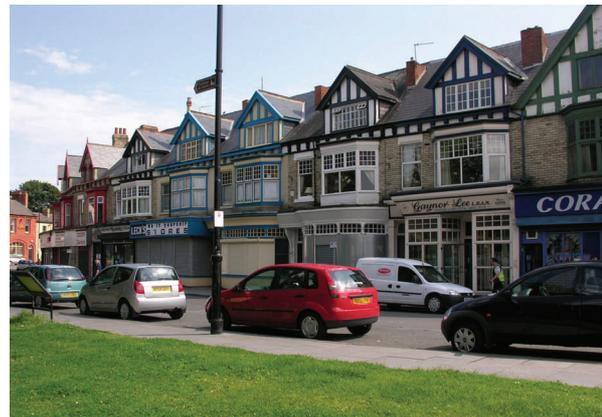
7. Fronting on to Stranton Garth is a small parade of shops all three storey with the third floor accommodation in the roof space constructed in a pale, cream brick which is known as Pease brick (see photographs below). The buildings have varying styles of dormer windows, some set back into the roof with decorative barge boards and others spanning the front of the property with timber and render detailing. The shops have been altered over the years, however, they retain enough original features such as the wooden bay windows, corbels and original openings to show the character that once existed.

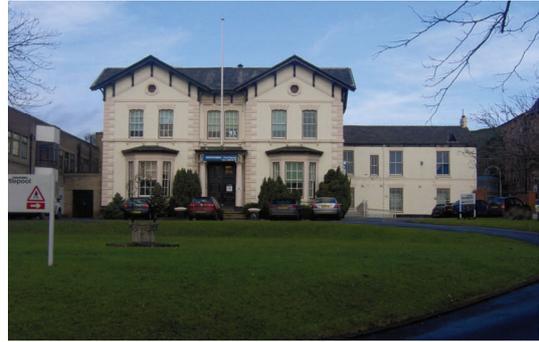
8. Housing Hartlepool occupies a property called Greenbank (photograph to right). It is set in its own grounds behind a high wall that fronts the green. The building is elegant and retains many of its original features despite being largely extended. It also provides a snapshot of the few large residential properties that once existed in this area.

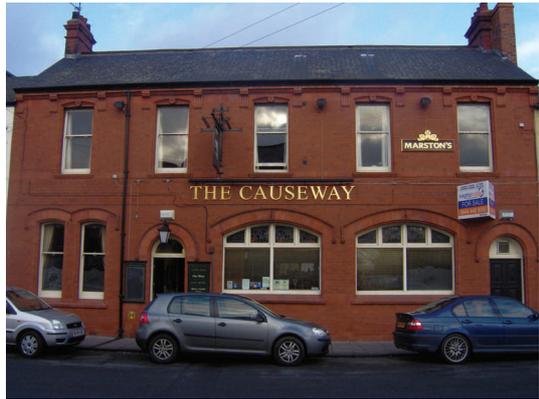
9. The Causeway Public House is an attractive redbrick building that has retained traditional features such as sash windows, doors and tiling in the entrance. It is located in the centre of a small terrace of three properties.

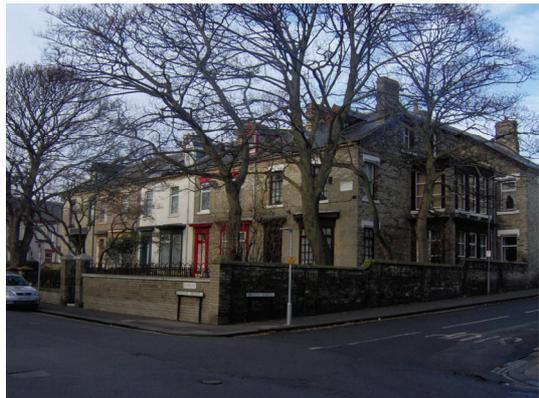
10. Bathgate Terrace (photograph to right) is a small row of five residential properties on the west side of the area, two storeys in height with some extending into the roof space evident by the small dormer windows. Although some of the windows and doors on these properties have been changed the buildings have retained much of their original character. Openings remain the same retaining the rhythm of the terrace. In some instances original railings can also be found to the front of the property providing an example of what the boundaries of these properties once looked like.

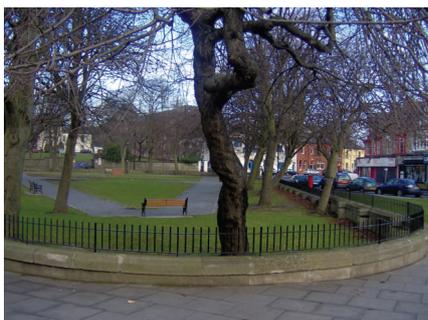
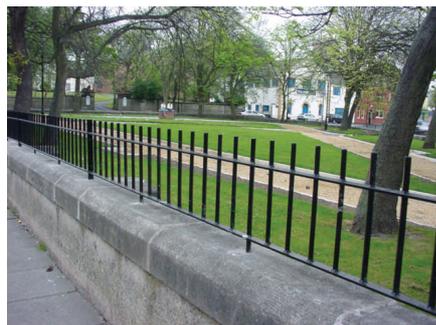
12. The main open space in the area is Stranton Garth to the south. Historically the area was once part of the gardens to West Hall a large property in the area. It is now a focal point for the area with the parade of shops overlooking it. The area has been landscaped and has some attractive mature trees; it is enclosed by a low wall. Seating areas have been provided. Despite the proximity of busy roads the area has a quiet feel.

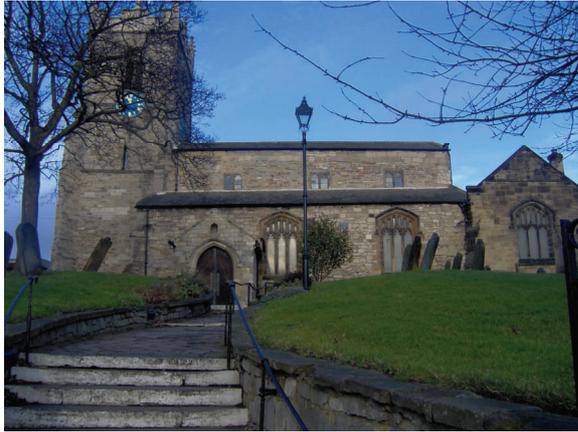
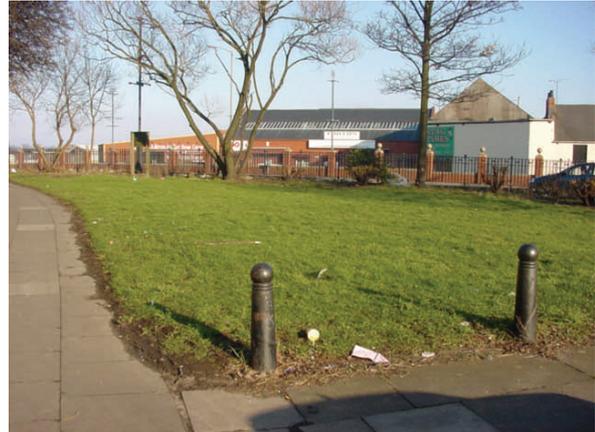
13. The church is set in a pleasant green area and includes mature trees and some flowerbeds (see photograph above). It is raised from immediate public view and therefore appears to be less accessible than Stranton Garth

14. There are other smaller areas of space including the area adjacent to the large retail unit to the south and at the end of the parade of shops (see photograph above). Both include trees and landscaping but are in poor condition and contribute very little to the setting of the buildings in the area. Despite this as the areas can be viewed from the public realm they do contribute to the feeling of “greenness” in the area.

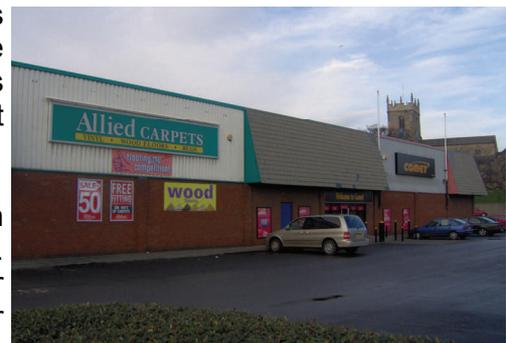
19. Two large retail stores are located to the south east side of the area (see photograph to right). This part of Stranton has a modern character in comparison to the rest of the area however it is an important space to the front of the church and a key site in the context of the conservation area.

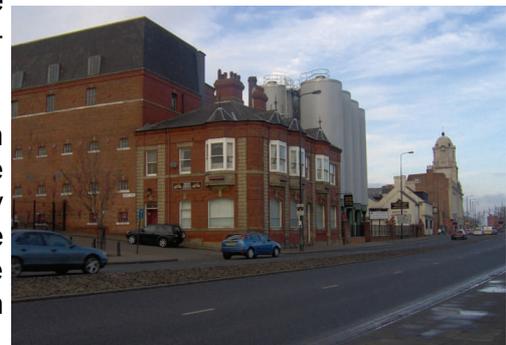
20. A large part of the brewery site are modern structures (see photograph to right). These areas are functional and reinforce the identity of a modern working brewery. Such areas are not particularly special however, they provide a link between the original red brick Victorian buildings.

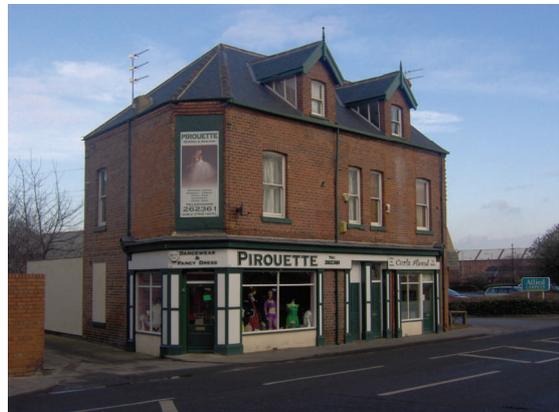
3. Further to this a number of commercial properties have benefitted from grant. Wholesale changes were made to the shopfronts and upper floors of 62 and 64 Burn Road restoring traditional shopfronts to the properties and providing windows and doors to the flats over these shops. In a similar vein the property adjacent to the Causeway Public House was restored with grant assistance enabling the existing business to extend into it (see photographs to right).

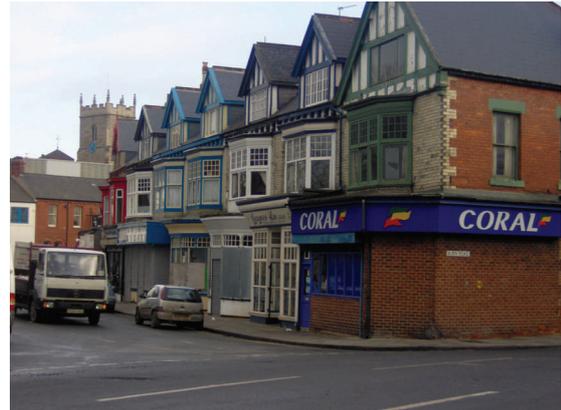
3. The majority of the commercial properties on Vicarage Row are occupied and in the past a number have benefited from grant funding for re-roofing works. The introduction of the conservation area encouraged the restoration of shopfronts on two properties in Burn Road however this has not impacted as much on those shops in Vicarage Row. For the most part the shopfronts remain unchanged and an emerging issue is the incremental changes which continue to be made to properties.

4. Integrating a roller shutter into an existing shop front can be difficult, often disrupting its design and appearance, particularly so if the frontage is a highly detailed original example. External shutters may in some cases be the only alternative if owners' understandable concerns to protect their properties are to be addressed and the quality of the shop front preserved. However such an approach can have a detrimental effect upon the character of Stranton as a conservation area. There should be investigation of alternative approaches to help owners protect their properties rather than adopting external shutters to both protect the character of the area and address some owners' needs to protect their properties.

2 **Building appearance** - The report indicates the quality of the conservation area is reduced by inappropriate alterations to buildings, poor design and maintenance in the context of a conservation area. The report noted the example of properties in Vicarage Gardens where all the traditional appearance has been lost by inappropriate alterations. Long continuous horizontal frontages have removed the variety and interest that a number of differing traditionally detailed frontages would provide. Part of the solution to achieve an improvement would be to provide building design advice to owners particularly concerning shop front design. A leaflet "Shop front Design Guide" already exists along with a Supplementary Guidance Note in the Local Plan providing guidance on shopfronts and advertisements. These could be adapted and expanded in a leaflet to be applicable to Stranton.

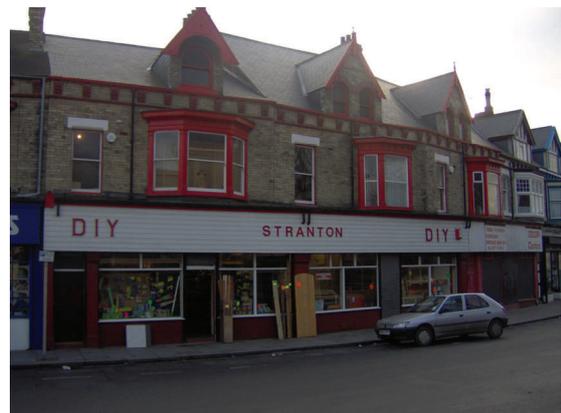
5. The design of adverts to properties in the form of fascia signs to shop fronts and hanging signs to front elevations and their illumination can enhance the quality of a building and the conservation area. The choice of materials, style or font type for letters used, the colours used for backgrounds and letters and the way the advert is illuminated are some of the detailed issues which need to be addressed to achieve satisfactory advert design. Design advice made available to owners and agents who submit applications would be a means to address this design issue.

3. **Design of advertising** – The type of design and detail of advertisements to buildings and shop fronts can have a positive impact on the appearance of Stranton as a Conservation Area. The leaflet on "Shop Front Design" mentioned above could be adapted to address good design of advertisements on buildings and shop fronts in the context of a conservation area. The integration of roller shutters into the overall shop front design can enhance the character of individual buildings and the wider appearance

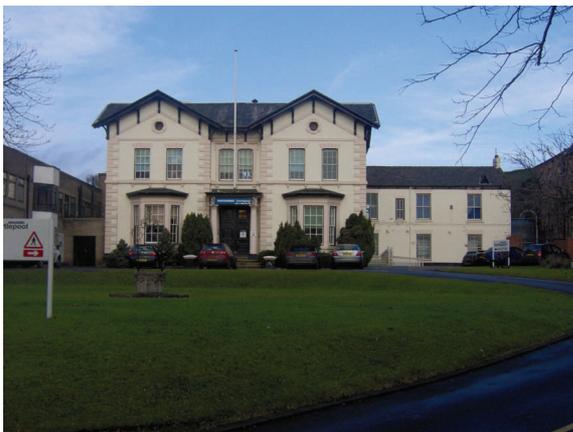
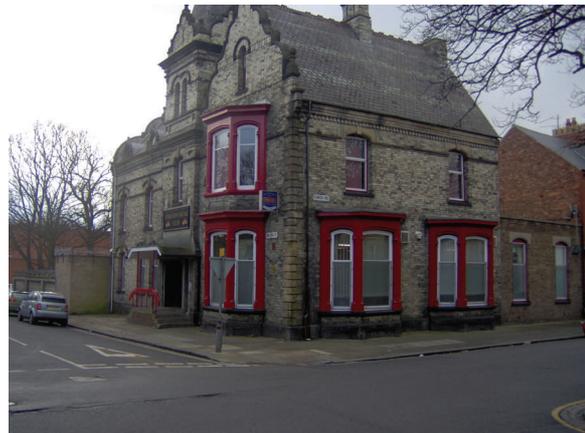
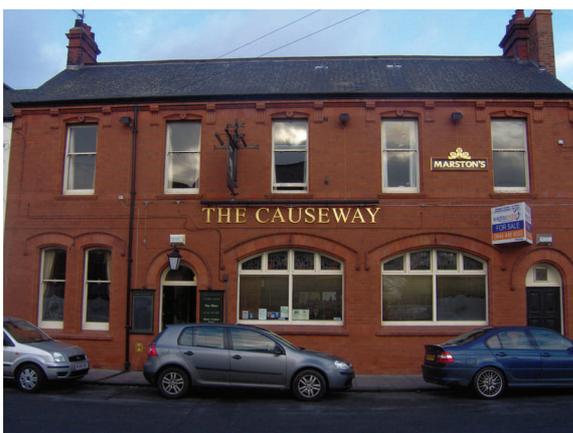
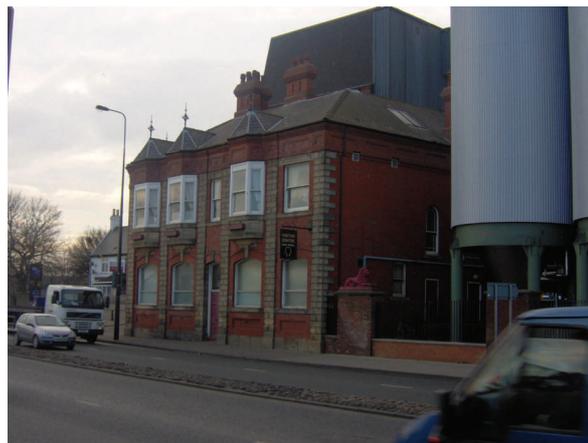
7 Besides the identified listed buildings there are a number of significant other buildings identified at the beginning of the assessment which add to the overall quality of the Stranton Conservation Area, due to their individual architecture and materials used. Their quality would not be sufficient to justify listed status in their own right but inclusion on a local list of significant buildings would be a material consideration if there were a proposal to demolish. A local list of significant buildings is currently being considered. Potential buildings for inclusion in a Local List of significant buildings have been identified as:

Photographs showing potential locally listed buildings from top left, Greenbank, Social Club, Waldon Street, The Causeway, Cameron's Brewery.
