HERITAGE AT RISK IN HARTLEPOOL 2013

State of the historic environment in Hartlepool at a glance

This document was agreed by Planning Committee on 25th September 2013. It is the Council's intention to review this list annually to ensure that the information contained is correct and an accurate reflection of Heritage at Risk in Hartlepool.

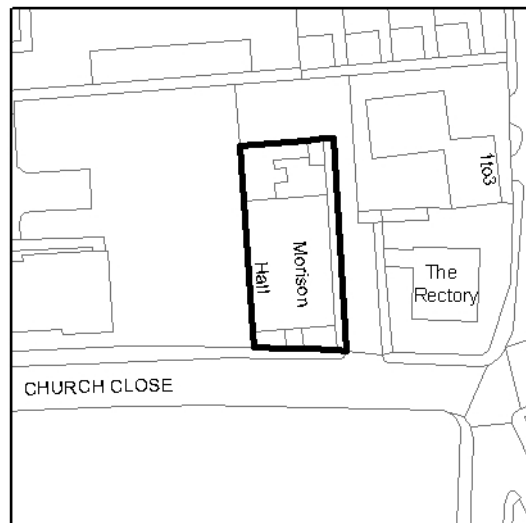
Condition *Poor*

The external fabric of the property is in a reasonable condition. A grant was provided in 1998 for re-roofing and structural works. The building has been secured with windows and doors boarded to prevent entry. Recent internal inspections suggest that little maintenance of the building has taken place since it became vacant. There is some limited damage to the interior from the fire but the property appears, for the most part, to be sound.

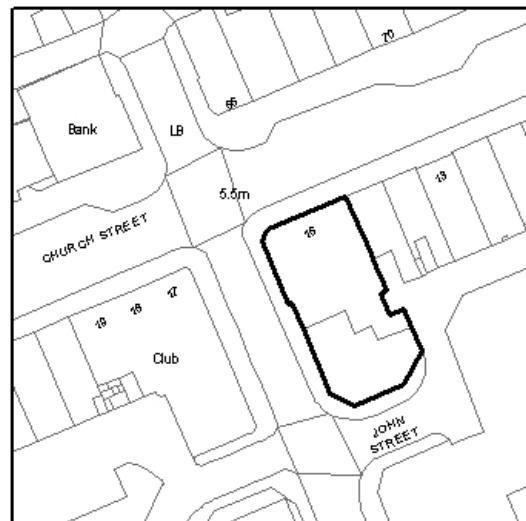
Condition *Very Bad*

It is believed that there may be structural problems in the upper floors of the building. Alongside the internal issues the exterior of the property has not been maintained. As a result the faience has deteriorated with parts breaking off. The Local Authority has been in contact with the owner regarding the external condition of the building after concerns that it may be endangering public safety. Vegetation can be seen growing in the guttering and much of the render to the upper floors is cracked with paint work peeling off. Formal action by the Local Authority using the powers it has available relating to listed buildings has been initiated to seek protection of the building and re-use.

Suitable future uses for the building could be to continue the existing use in a restored building or commercial uses similar to those found elsewhere in Church Street.

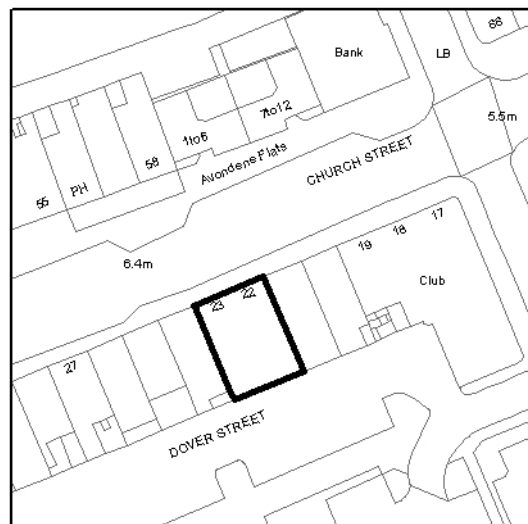
Condition *Poor*

It appears to be sound and secure but there are signs of deterioration to the exterior of the property. The longer the building remains empty the more likely it will be that it continues to decline. Further to this the accumulation of vacant buildings within conservation areas, such as Church Street is experiencing, can have a negative impact on the area as a whole.

Suitable future uses for the building could be to continue the existing use in a restored building or commercial uses similar to those found elsewhere in Church Street.

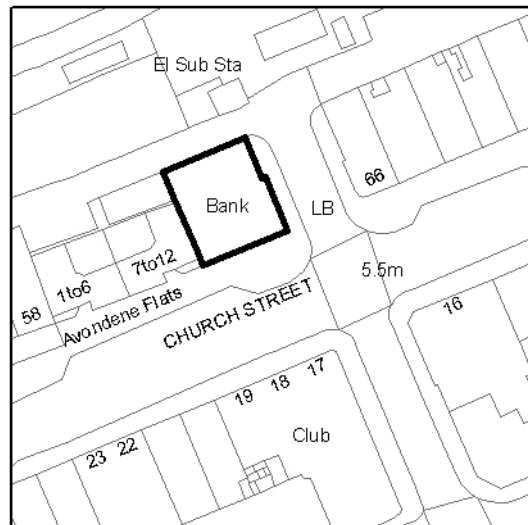
Condition *Poor*

Its current condition is poor and with the building showing little sign of being maintained on a regular basis. Cracking to the exterior of the property could be an indication that there are structural issues with the building. There is not a long term plan for the re-use of the property. The longer the property remains empty the more likely it will be that it deteriorates. Further to this the accumulation of vacant buildings within conservation areas, such as Church Street is experiencing, can have a negative impact on the area as a whole.

Previous uses of the building i.e. banking and those approved through the planning system (antiques centre and art gallery or general retail) would be acceptable. Alternatively the structure may be used for a commercial use similar to those found in the vicinity.

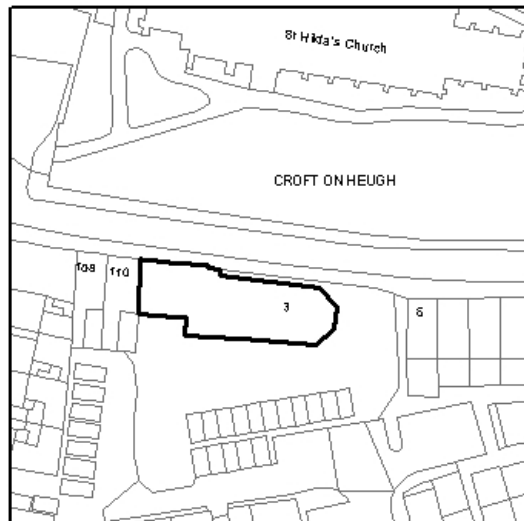
Condition *Fair*

A change of ownership has occurred with the new owners implementing a scheme of alterations to the building (based on the consents detailed) to create improved kitchen and toilet facilities and greater utilisation of the building internally. As part of the scheme, work to the building is to be undertaken to address the backlog of maintenance, including render repairs, replacement of guttering and downpipes, repairs to windows and decoration. The intention is to still use the building as a social club as before, but to extend the use to wedding receptions, training events and conferences.

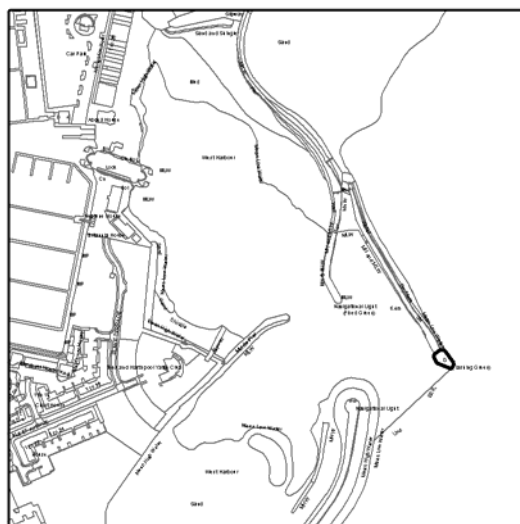
Condition *Poor*

The nature of the structure means that it is isolated and not readily accessible. The light does not appear to be maintained and shows signs of deterioration in the form of rusting to the main column. The sandstone plinth is also in a poor state of repair with the edges of the stonework badly damaged.

Due to the remote location of this listed building and with no formal, regular maintenance in place it would appear that the structure will continue to slowly deteriorate.

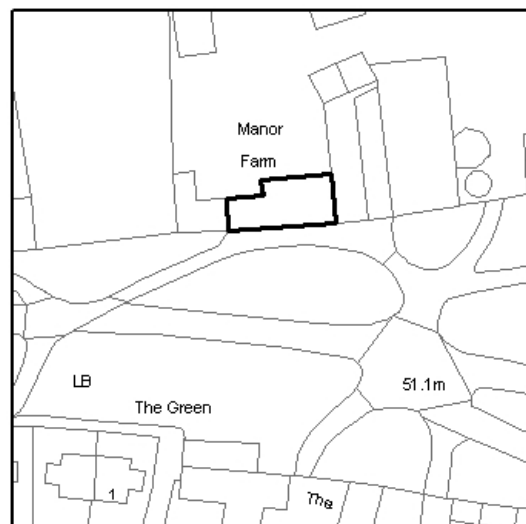
Condition *Poor*

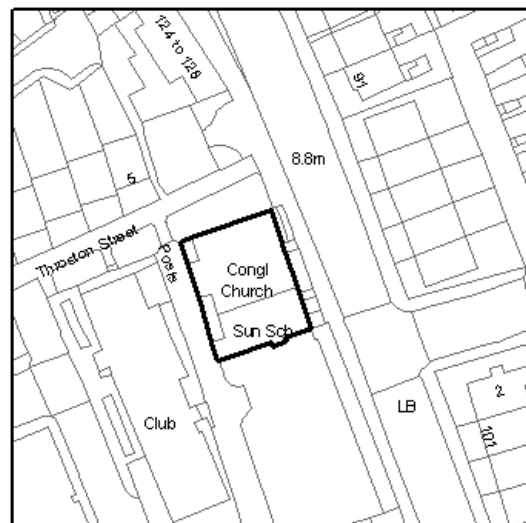
Condition *Poor*

Works to the Church however have been sporadic. Some of the external works have been completed consisting of window replacement and the creation of new window openings as part of the consent. The internal conversion works to form the apartments is largely incomplete. However the ownership of the building has recently changed. The Church will still be vulnerable and its future uncertain until the intentions of the new owner are clear and the outstanding consent fully implemented with all the apartments largely occupied.

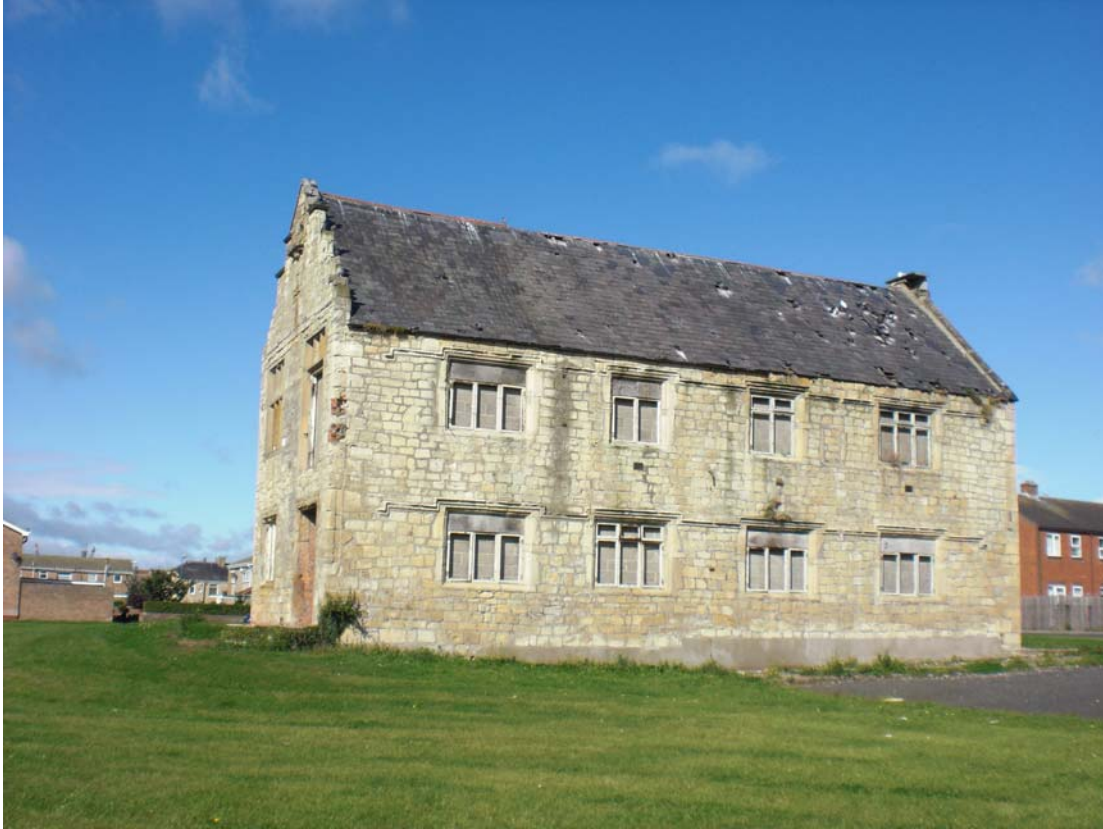
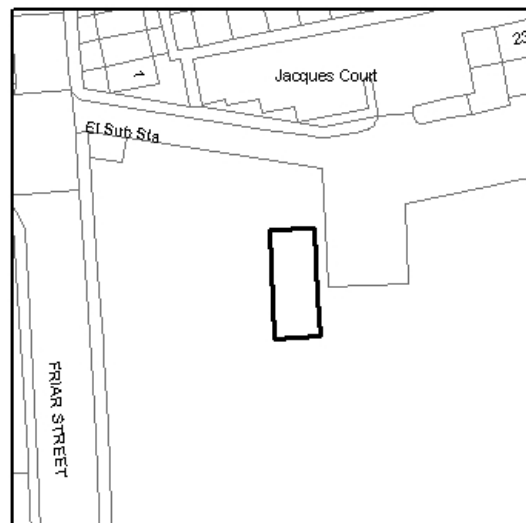
Friarage Manor House, Friar Street

Condition *Poor*

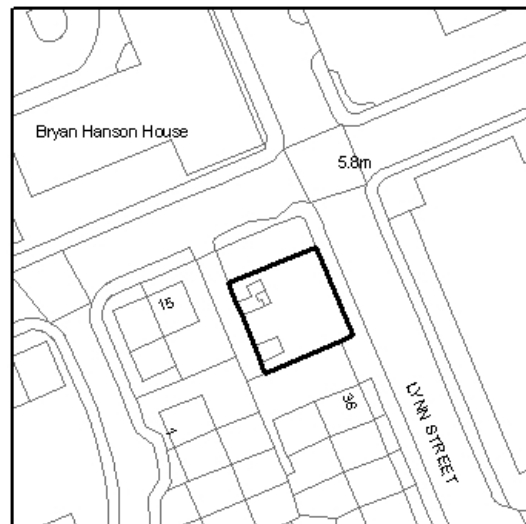
Condition *Poor*

Despite being vacant for a number of years the building is secure and is considered to be in a reasonable state of repair.

All of the windows have been boarded up to ensure that the building is watertight and secure. The property is rendered but this has been removed from the elevation facing Surtees Street leaving the brickwork exposed after an area of render was deemed to be of concern. To the front of the property the faience has been painted but this has begun to peel off revealing the tiles below. Although the tiling appears to be in good condition, with minor repairs required, the peeling paintwork is unsightly.

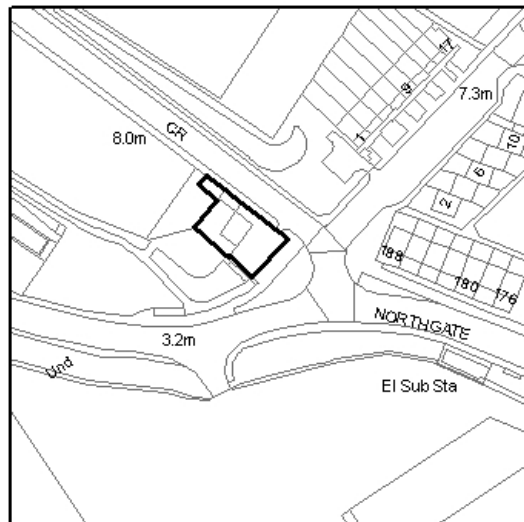
Throston Engine House, Old Cemetery Road

Condition *Very Bad*

A long term structural crack evident on the south-east elevation has widened, necessitating a supporting scaffold to the east corner of the building to prevent a potential collapse. On the opposite corner of the building vandalism damage (consisting of area stonework being removed) has been re-built in a concrete block. Overall the structural integrity of the building is under threat.

The ownership of the building has changed recently. Until the intention of the new owners becomes clear and a firm commitment is made to addressing the structural condition of the building, its exposure to the weather and lack of complete security, places the long term future of this listed building in doubt.

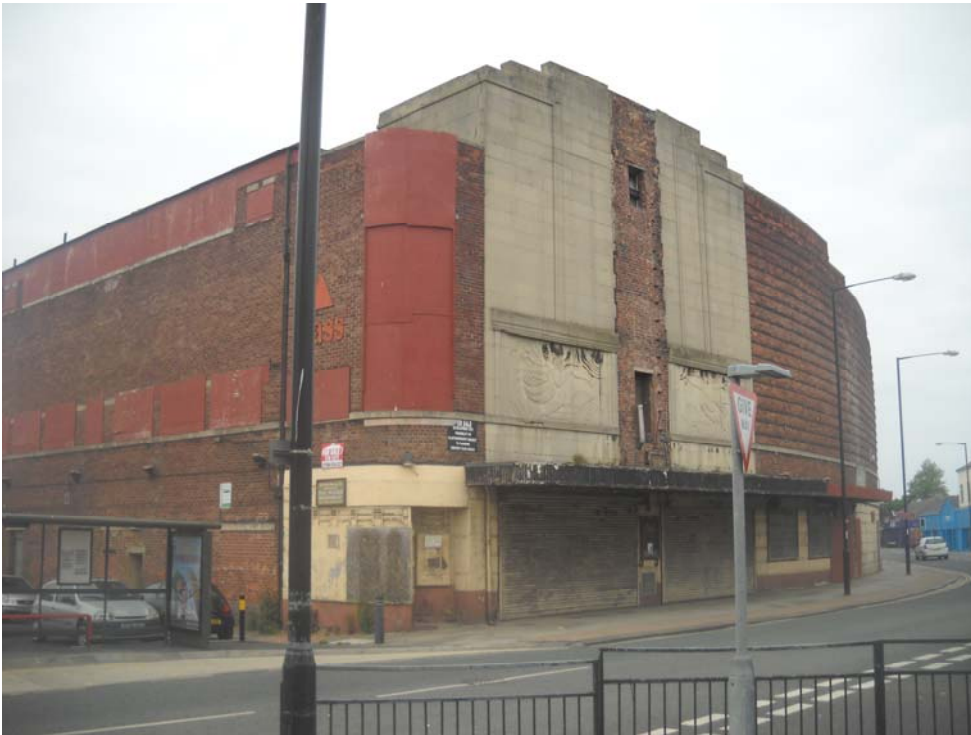
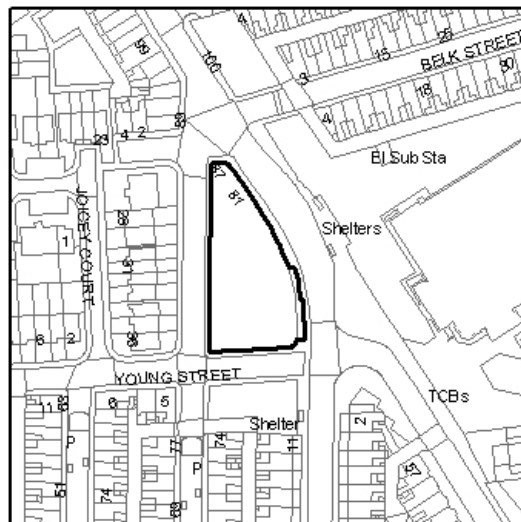
Former Odeon Cinema and 81 – 87 Raby Road

Condition *Poor*

As with so many cinemas from this date it is no longer in operation. A new use was found temporarily as a night-club, but this too has now ceased and the adjoining shop units are empty.

The local authority is seeking a suitable development partner who can deliver a sustainable and viable scheme through a back to back deal that will lead to the renovation and re-use of this property. For further information please contact Andy Golightly 01429 284009

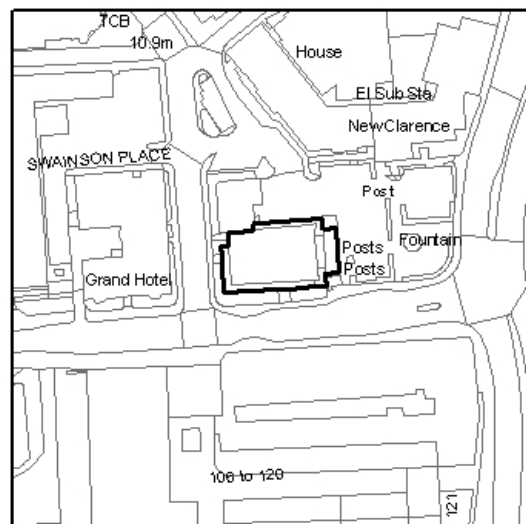
The majority of the building has been vacant for a significant period. The building has suffered from low level vandalism consisting of broken glass to windows and occasional break-ins. There has been little maintenance carried out to the exterior of the building with vegetation growing in the guttering at points around the building causing overflows and wetting of the walls. Vegetation is also growing at points in the walls. Approaches by the Council to the owner to board windows and clear vegetation have largely been acted upon, however vandalism damage is still occurring (in the form of lead theft) and vegetation growth continues in places. Overall the main fabric of the building seems sound, including the roof which appears water tight.

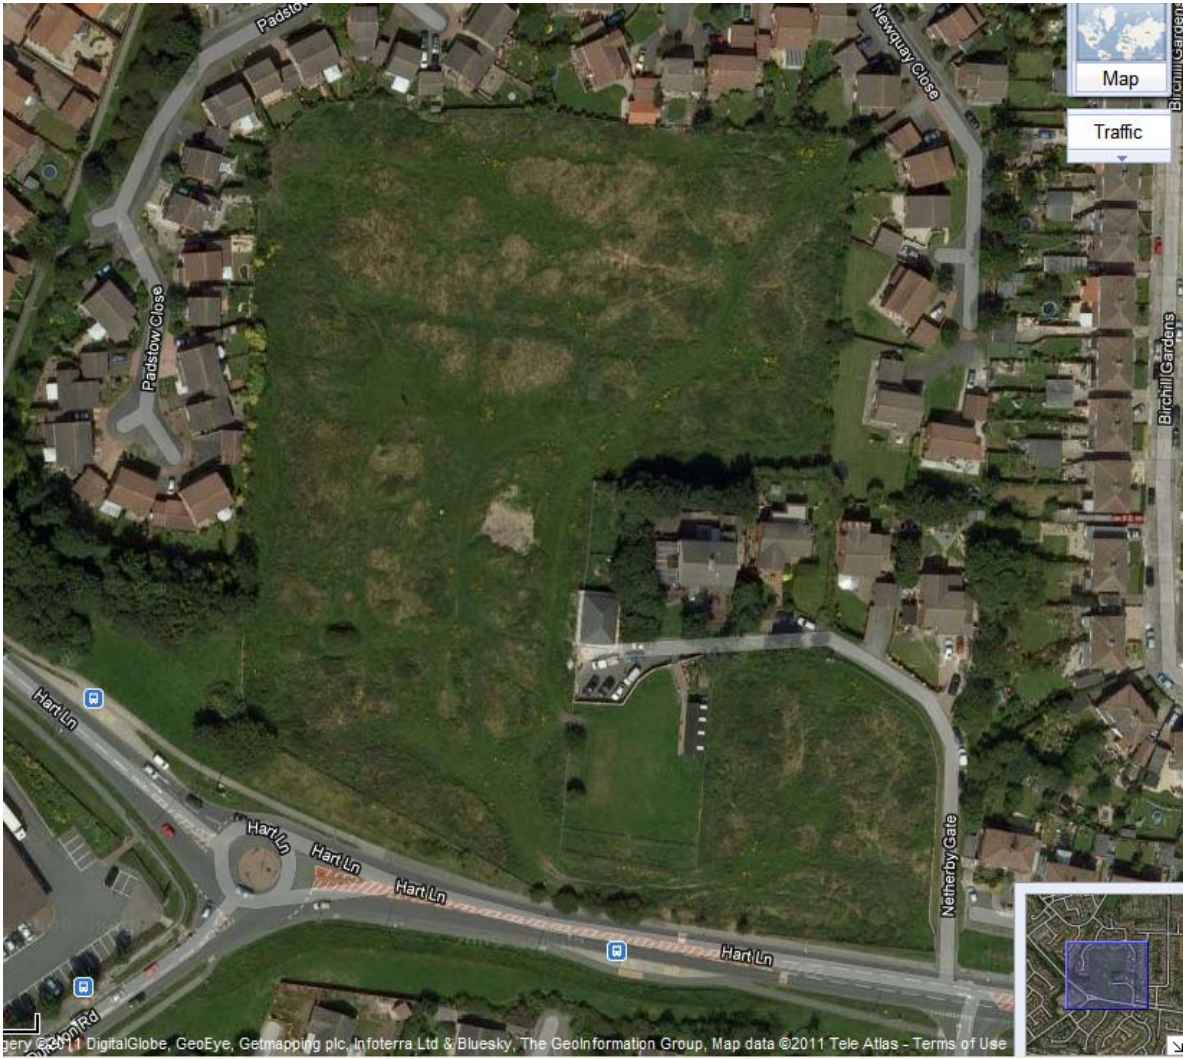
Low Throston Deserted Medieval Village

Condition *Generally satisfactory but with significant localised problems*

Principal Vulnerability: *Deterioration – in need of management*

Trend *Declining*

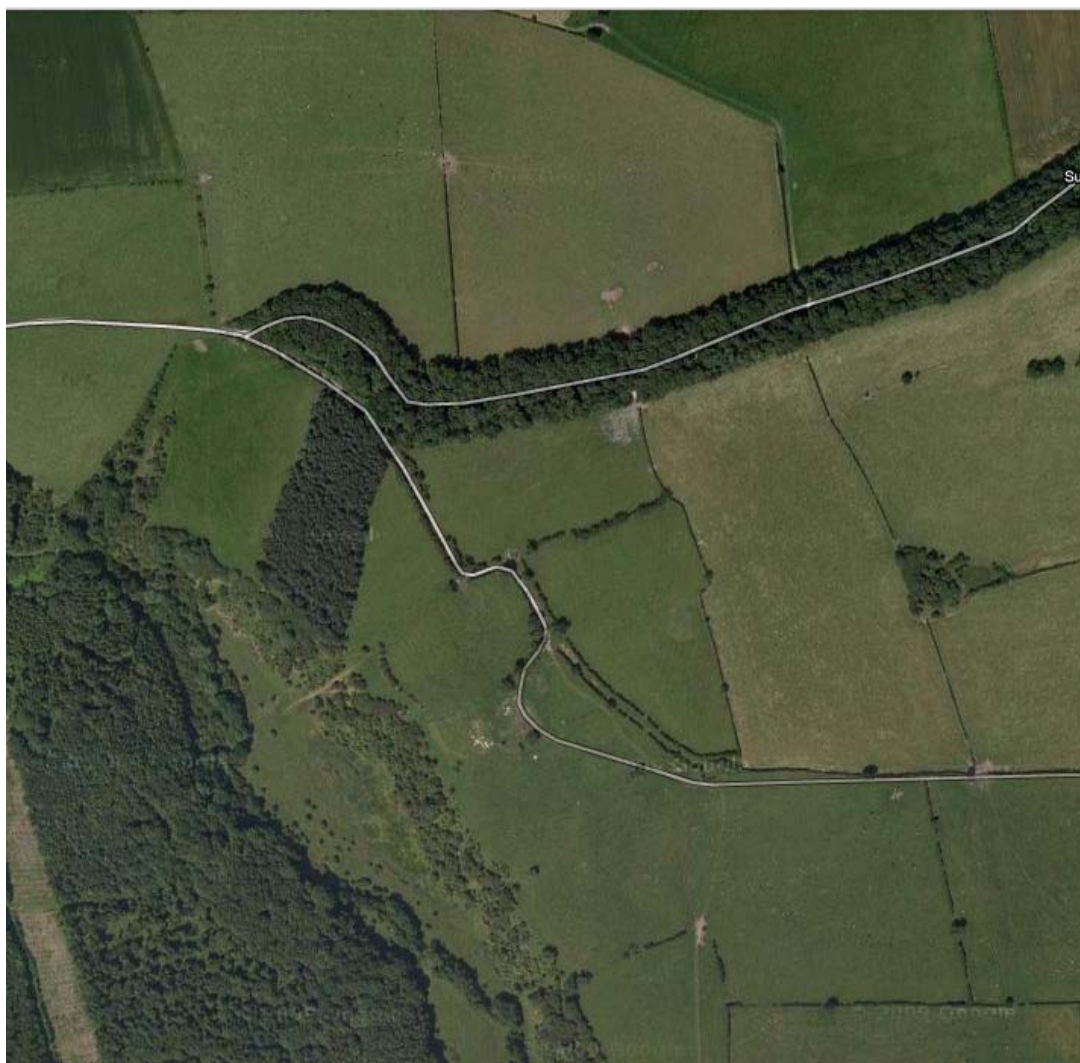
Medieval Farmstead and irregular open field system at High Bruntoft Farm, Elwick

Condition *Generally unsatisfactory with major localised problems*

Principal Vulnerability: *Extensive vehicle damage/erosion*

Trend *Declining*

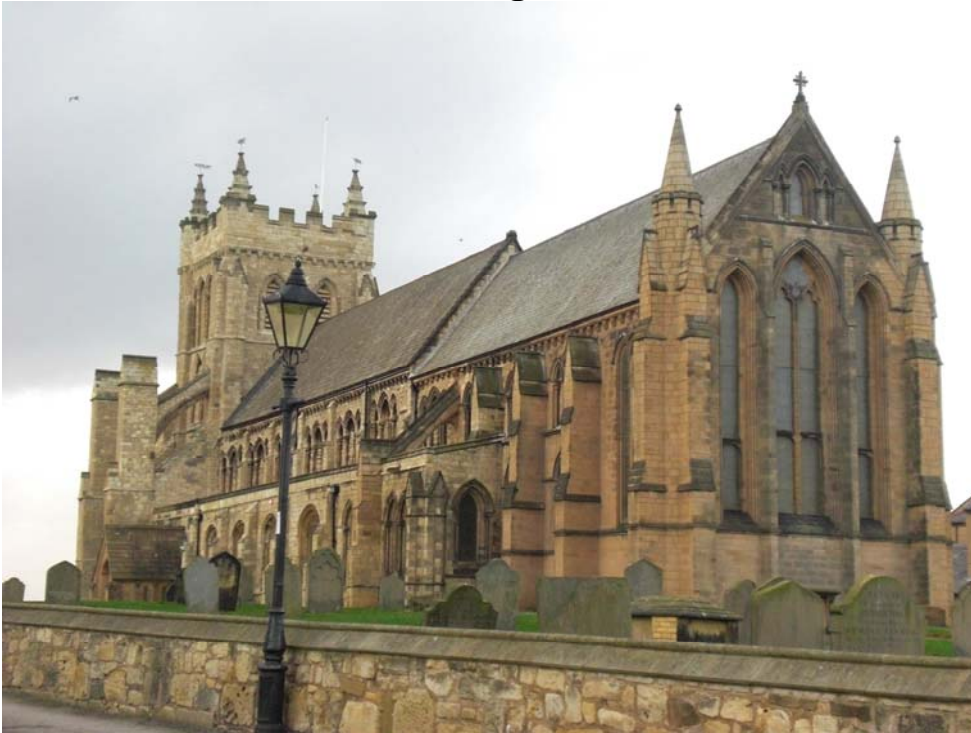
Church of St Hilda, High Street, Headland

Condition *Poor*

Built around 1200 on the site of a C7 monastery, incorporating the remains of an early C12 church. Many Saxon and medieval architectural fragments throughout the church, which has undergone several re-designs and was fully restored between 1925 and 1932. The church is on an exposed site near the sea and the parapets (and other masonry) are open-jointed. In addition to having a spalling roof, the tower has structural issues that are currently under investigation. The building has also been the subject of heritage crime.

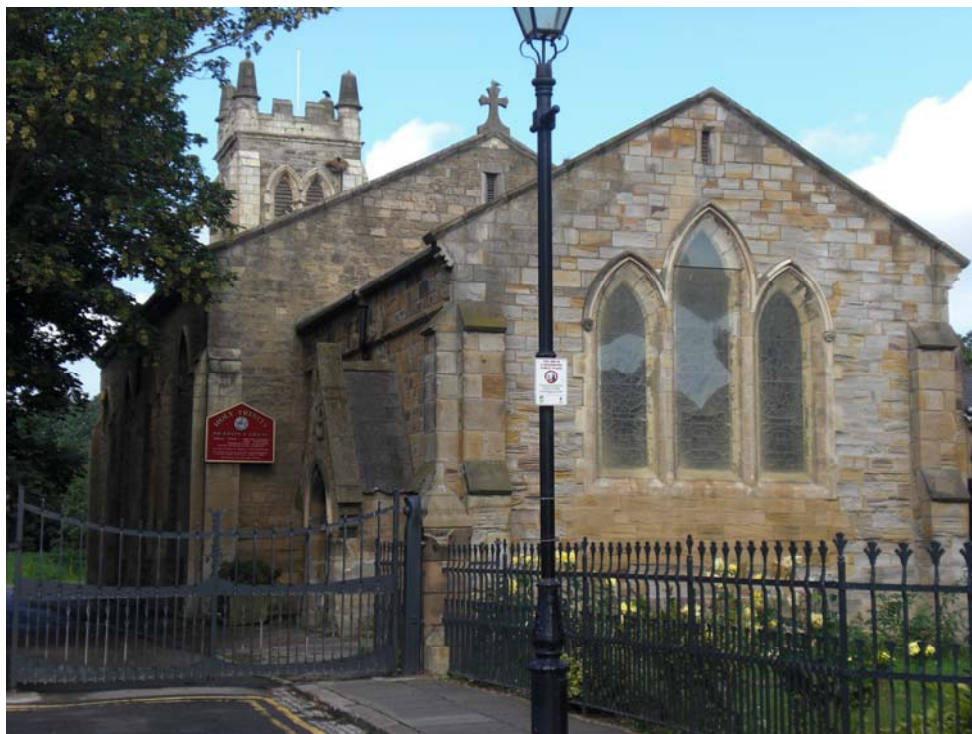
Church of the Holy Trinity, Church Street, Seaton Carew

Condition *Very bad*

Originally built as a chapel within the parish of Stranton, Holy Trinity was consecrated in 1831. Seaton Carew became a parish in its own right in 1841 and the church was extended, with a chancel and gallery built. Further alterations continued to be made to the building but some relatively recent repairs, using hard cement pointing, have accelerated the erosion of the stonework. Significantly repairs are now required to the roof structure, masonry and rainwater goods. A Heritage Lottery Fund grant was offered in March 2012 towards a project development and repair programme.

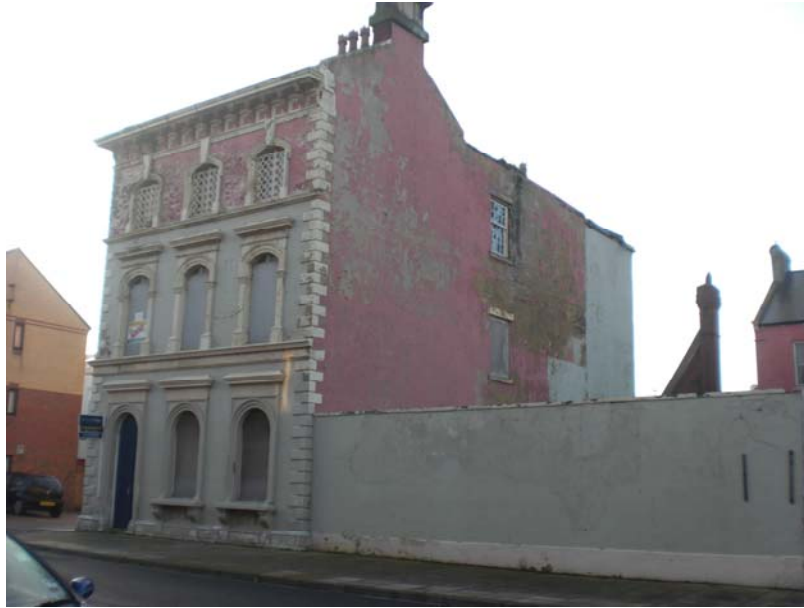
June 2011

Condition *Fair*

The ownership of the property changed and the current owner has carried out works to repair the exterior of the building, although work remains to be completed on the front of the building. The condition of the property now appears to be stable. Further to this the building is partly occupied suggesting that there is now a viable future for the property as apartments.
