HERITAGE AT RISK IN HARTLEPOOL 2013

State of the historic environment in Hartlepool at a glance

This document was agreed by Planning Committee on 25th September 2013. It is the Council's intention to review this list annually to ensure that the information contained is correct and an accurate reflection of Heritage at Risk in Hartlepool.

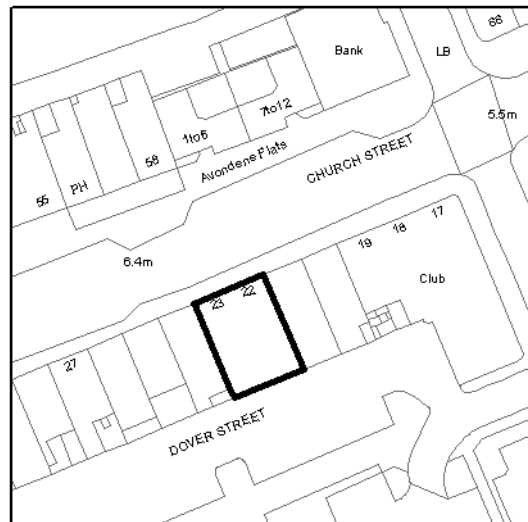
It appears to be sound and secure but there are signs of deterioration to the exterior of the property. The longer the building remains empty the more likely it will be that it continues to decline. Further to this the accumulation of vacant buildings within conservation areas, such as Church Street is experiencing, can have a negative impact on the area as a whole.

Suitable future uses for the building could be to continue the existing use in a restored building or commercial uses similar to those found elsewhere in Church Street.

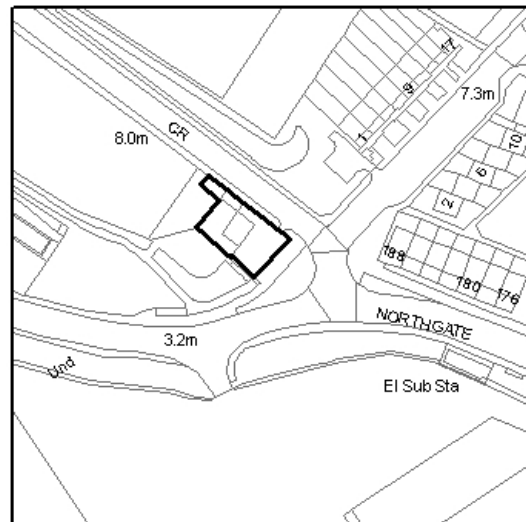
Throston Engine House, Old Cemetery Road

The Throston Engine House is located on an isolated site at the end of a defunct railway line from Durham, with very little in the way of surrounding supporting development. Its physical isolation has been a discouragement to any potential re-use of the building.

A long term structural crack evident on the south-east elevation has widened, necessitating a supporting scaffold to the east corner of the building to prevent a potential collapse. On the opposite corner of the building vandalism damage (consisting of area stonework being removed) has been re-built in a concrete block. Overall the structural integrity of the building is under threat.

The ownership of the building has changed recently. Until the intention of the new owners becomes clear and a firm commitment is made to addressing the structural condition of the building, its exposure to the weather and lack of complete security, places the long term future of this listed building in doubt.

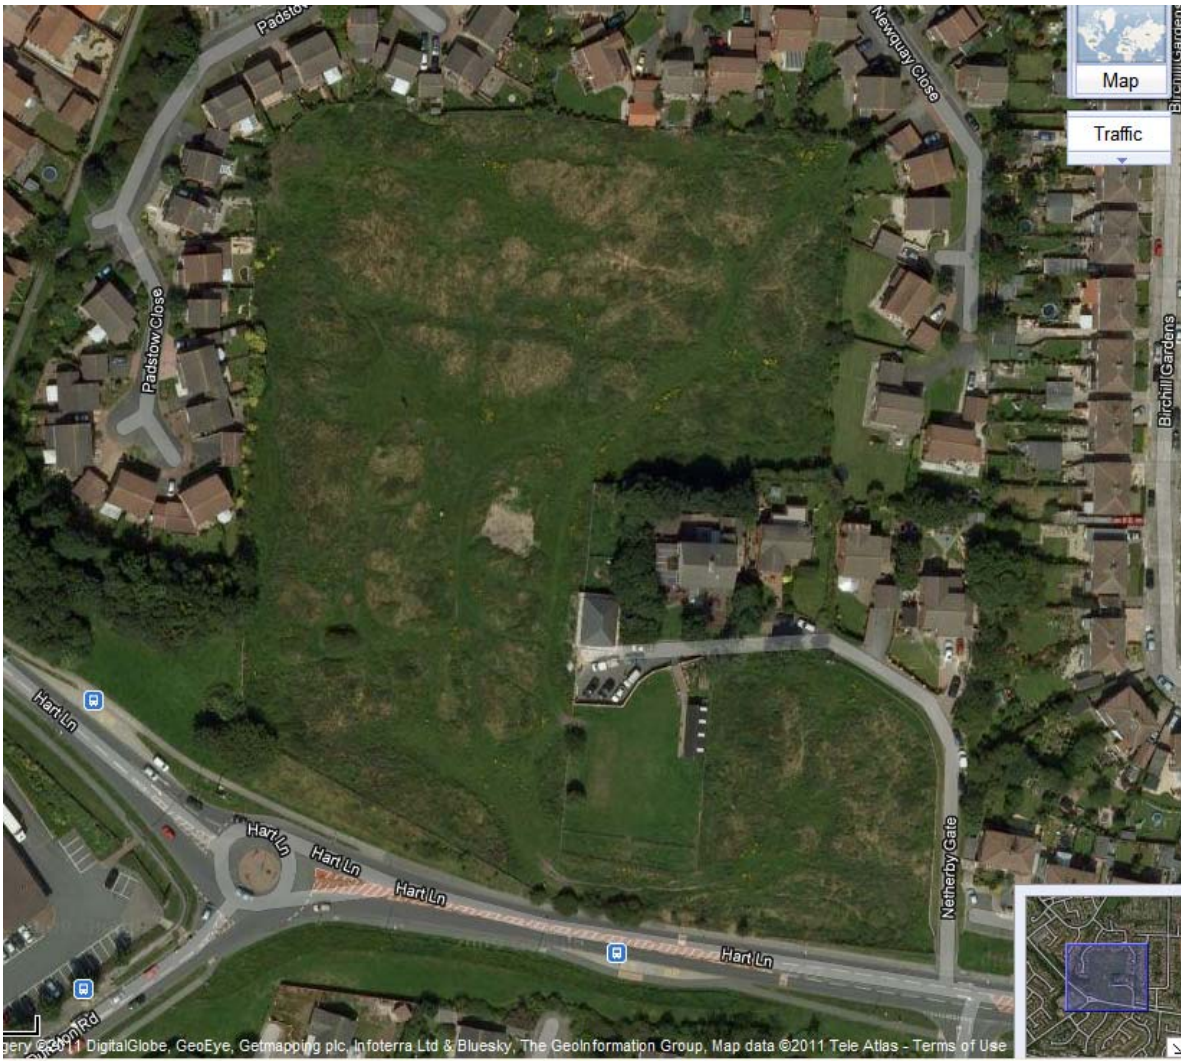
Low Throston Deserted Medieval Village

Condition *Generally satisfactory but with significant localised problems*

Principal Vulnerability: *Deterioration – in need of management*

Trend *Declining*

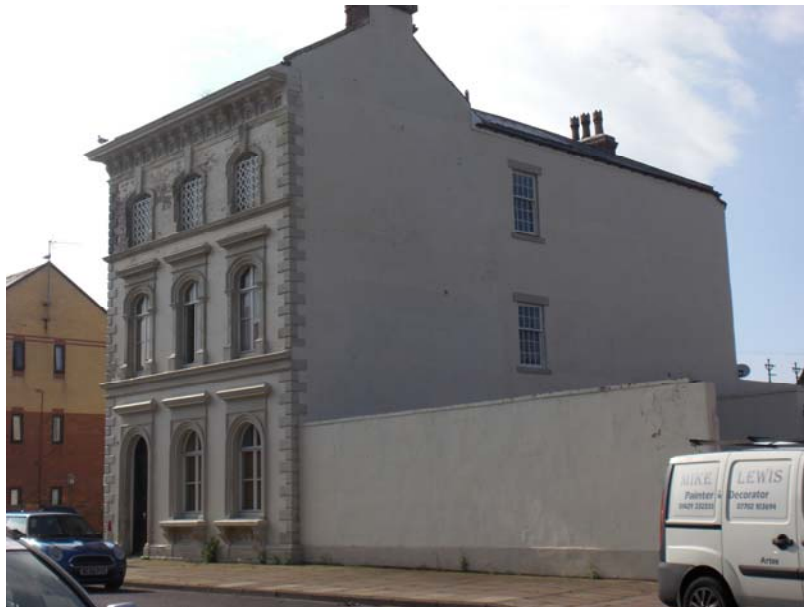
July 2013

The ownership of the property changed and the current owner has carried out works to repair the exterior of the building, although work remains to be completed on the front of the building. The condition of the property now appears to be stable. Further to this the building is partly occupied suggesting that there is now a viable future for the property as apartments.
